Situation report: Trishuli / Bhote Koshi flood, 2026-08-26

PRELIMINARY, 2026-10-12, commit `bf89060` + uncommitted changes (DRAFT)

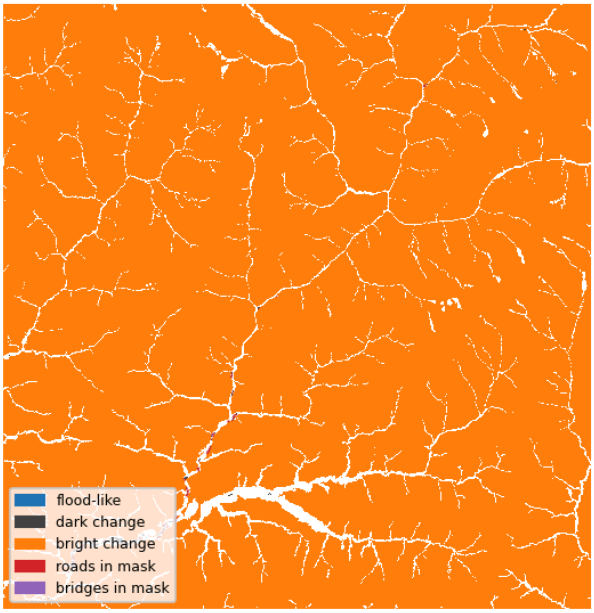
Situation. Event date 2026-08-26, Trishuli / Bhote Koshi, Rasuwa, Nepal. Sentinel-1 track asc85, 2026-08-16 / 2026-08-28: detector status **change_detected** (calibrated against pre-event nulls, null false-alarm max 0.035%; minimum detectable area ≈ 0.21 km²). Detected change on the valley floor is **not attributed to flooding, not a validated flood extent and not damage**. Counts below are exposure to that mask. Flood-like change (0.31 km² of water-like backscatter change) and surface change (2.29 km² dark, 0.54 km² bright) are each separable from all four pre-event nulls. An independent single-date water model could not separate the event from pre-event dates, and Sentinel-2 does not confirm open water.

Detected mask (unvalidated) and exposed roads/bridges
