AMSB with noise checking procedure

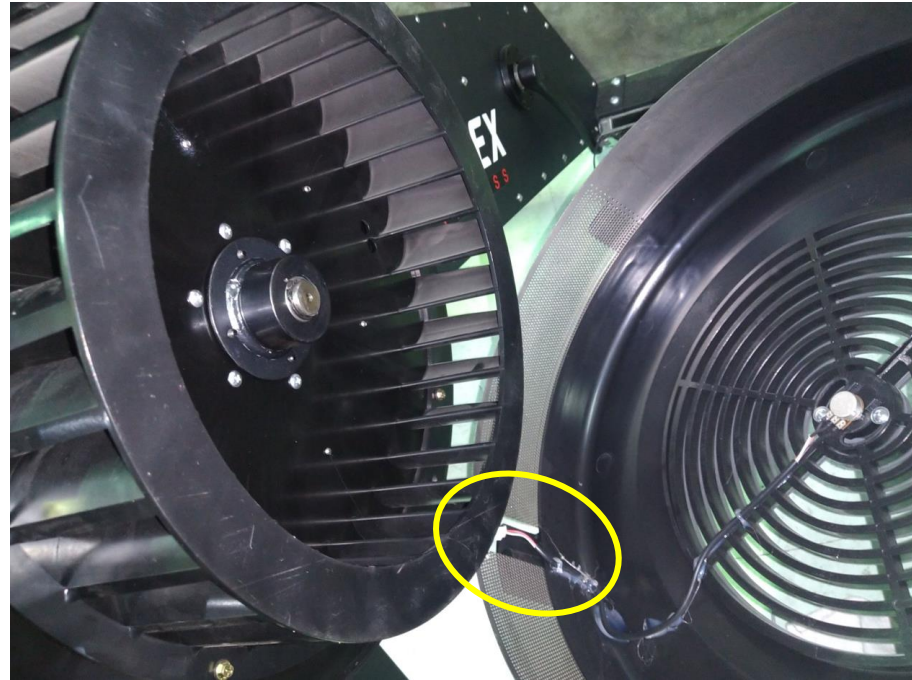
Unscrew 4x Screws

Disconnect the M2 VR cable

Remove the main cover

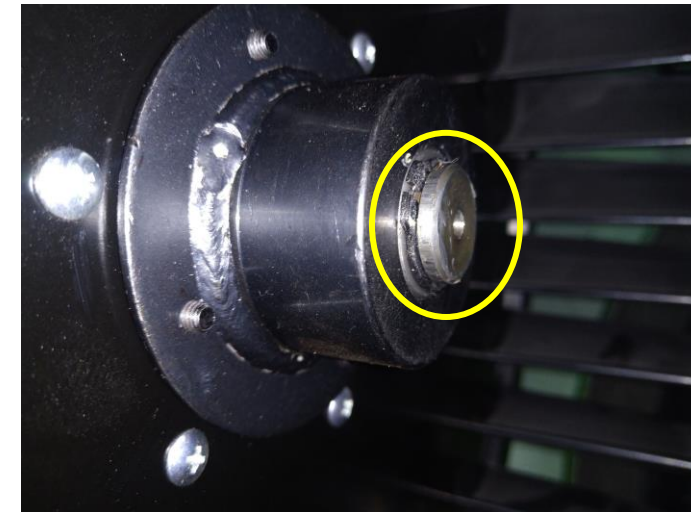
STEP 2: Please help to check if the E2 Clip is missing from the location circled in yellow as below?

Note: Sometimes the missing E2 will stuck to the inside of face of the E12 ring magnet as **picture 1**.

1- If E2 falls off and not at its place, then please put the #E2 Clip back to his original place.

2- If E2 is missing, then please replace to a new E2 Clip then can fix the issue.
