12396 Edgewater Drive, Unit/Lot 23

Hampton, GA 30228

Vacant residential lot · 1.3313 acres · Waterpointe subdivision · Clayton County, Georgia · Parcel 05050A A003 · Zoned RS180

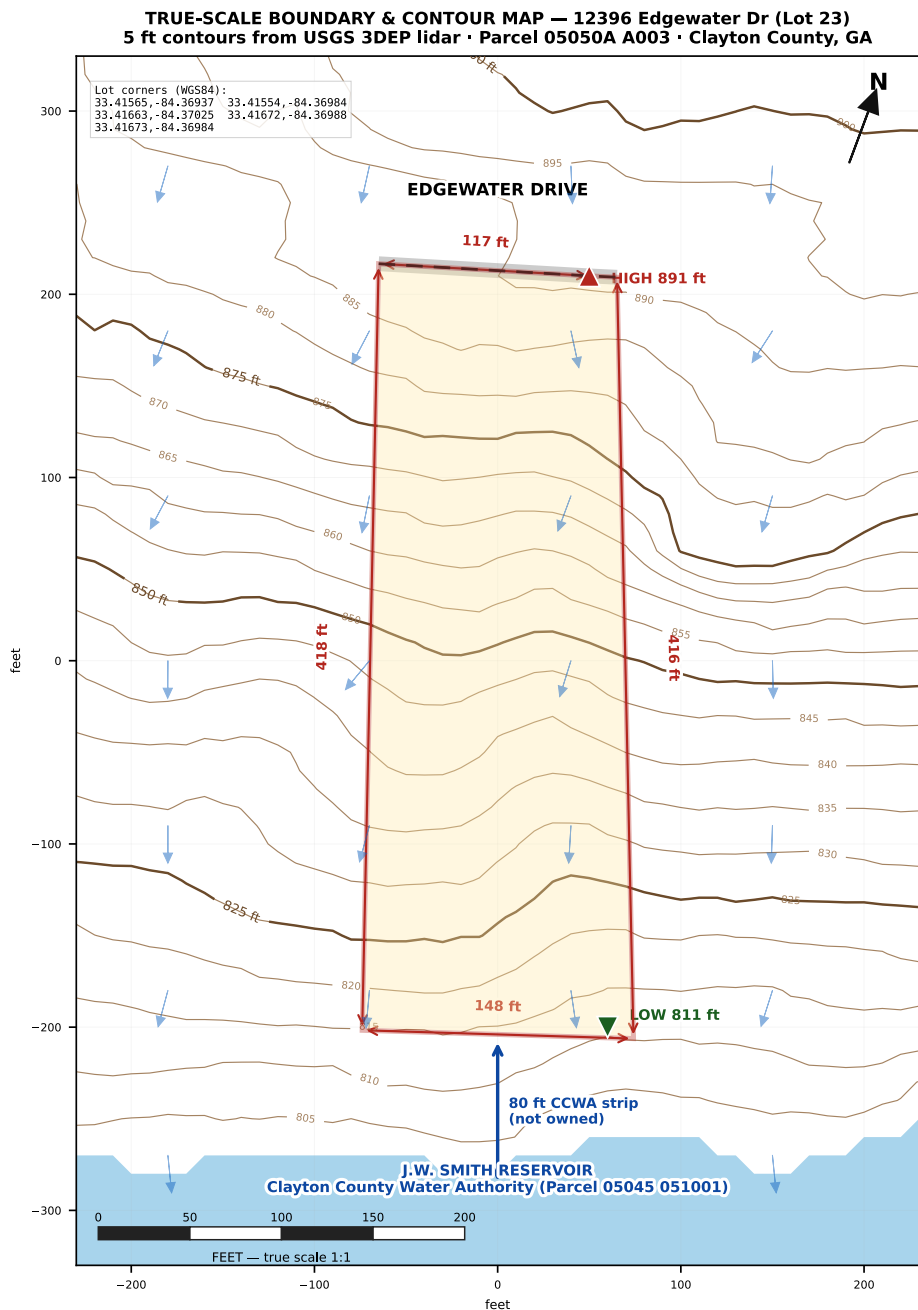
Figure 1 — True-scale plan. Horizontal scale is 1:1 (equal aspect); the scale bar is valid in both axes. Contours at 5 ft (labelled every 25 ft) derived from USGS 3DEP lidar sampled on a lot-aligned 10 ft grid (3,149 points, 583 of them inside the boundary). Blue arrows show computed down-gradient drainage direction. The lot has been rotated so the road-to-lake axis is vertical; the north arrow shows true north at 20.4° from the page vertical. **Contours are lidar-derived estimates, not a surveyed topographic map.**

Note how the contours run **almost perpendicular** to the lot's long axis and are **evenly spaced** — the signature of a uniform, planar hillside rather than a lot with a flat building pad and a drop at the back. The fall is continuous from road to rear boundary, and that is the central constraint on this site.

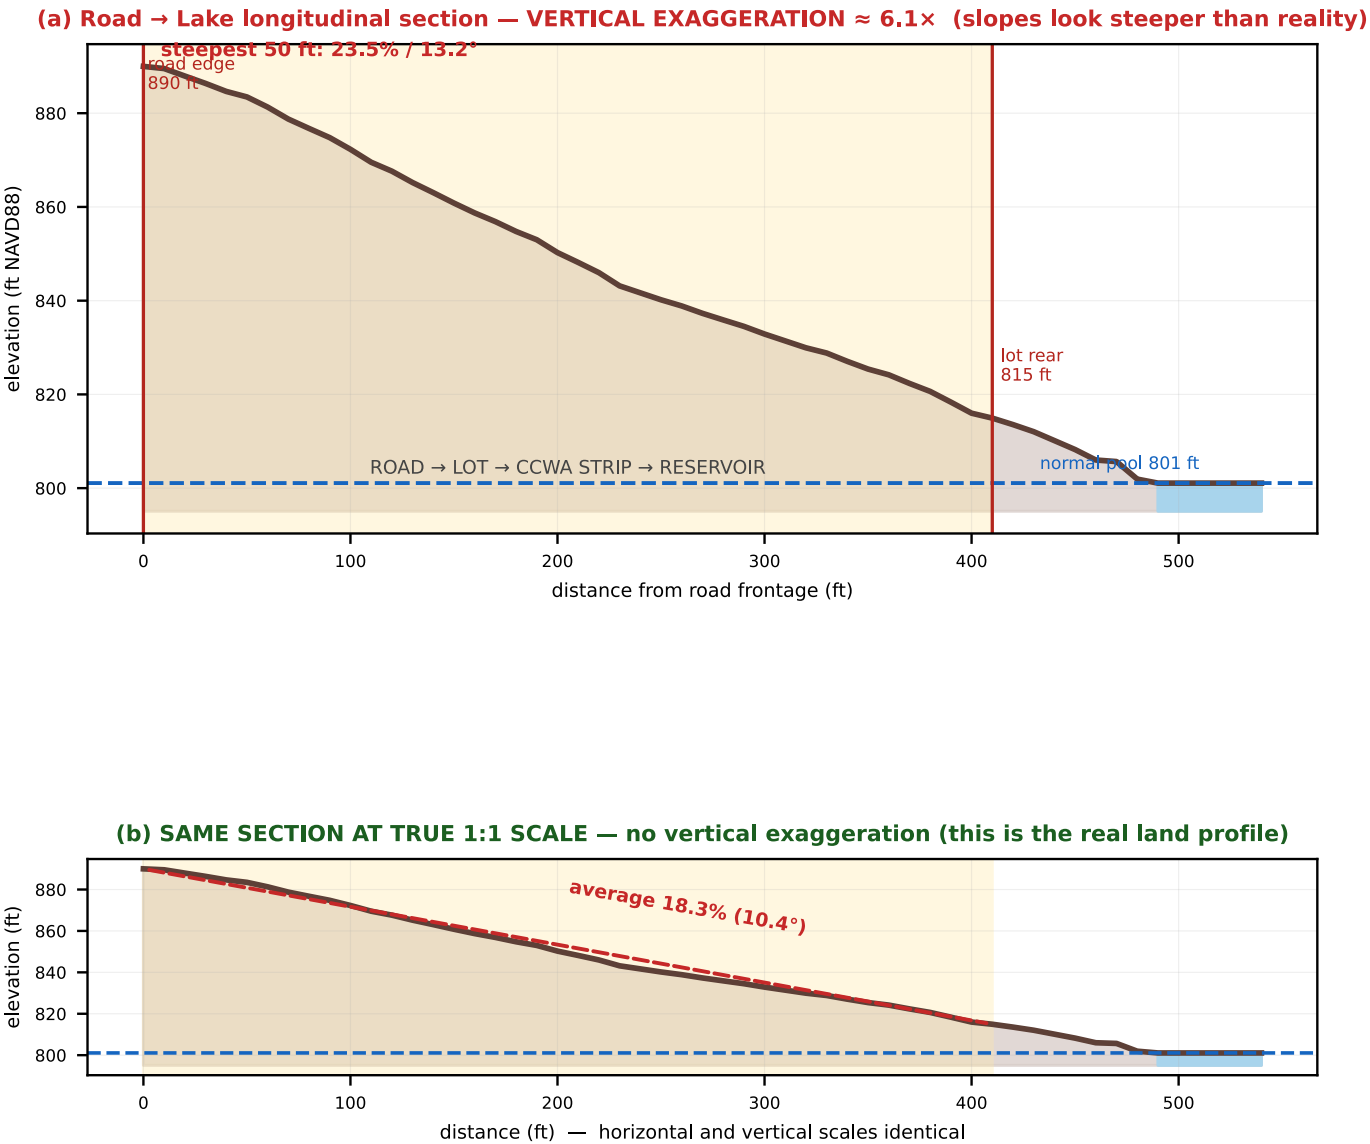
Figure 2 — Road → lake section. Panel (a) uses 6.1× vertical exaggeration, the conventional map presentation: the hillside looks severe. Panel (b) is the identical data at true 1:1 — the honest profile. The land reads as a steady, uniform grade rather than a cliff, but it never flattens: there is no natural level building pad anywhere on the lot.

The steepest ground is in the worst possible place

The 23.5% maximum occurs between 60 ft and 110 ft from the road frontage. After a front setback (RS180 front setback still to be confirmed), that band is exactly where the house footprint and driveway approach would normally sit. A driveway on 23.5% grade is unusable — residential driveways are generally kept at or below about 15%, with many jurisdictions stricter. Expect the design to require cutting into the slope, a stepped or daylight-basement foundation, and retaining structure.

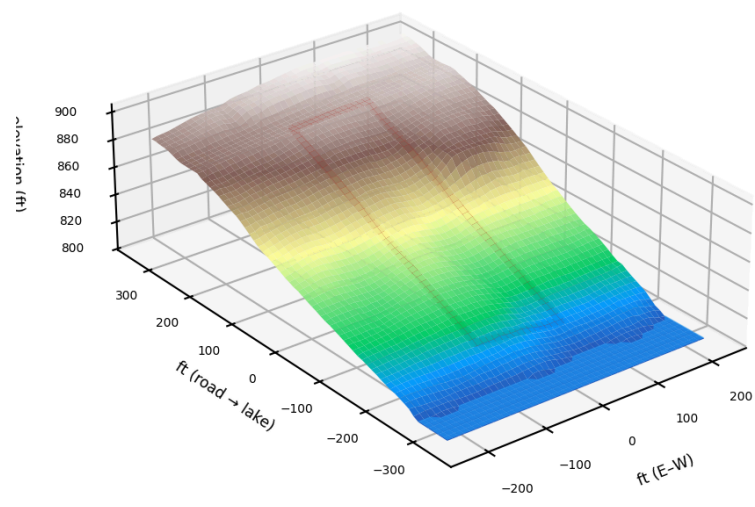
3D TERRAIN MODEL — lot boundary in red, reservoir in blue
USGS 3DEP lidar, 10 ft sampling · vertical scale exaggerated for visibility

Figure 3 — 3D terrain surface. Lot boundary in red, reservoir plane in blue. Vertical scale is exaggerated to make the surface legible (see Figure 2b for the true profile). The surface is a smooth, consistently dipping hillside with no bench or plateau inside the boundary.
