Two Georgia Lakefront Lots

A 61-point comparative due-diligence review, with measured terrain analysis, regulatory research and construction-cost modelling.

PROPERTY A 12396 Edgewater Dr #23, Hampton, GA 30228

PROPERTY B 1147 & 1153 Watersedge Cove, Lots 130 & 131, Tignall, GA 30668

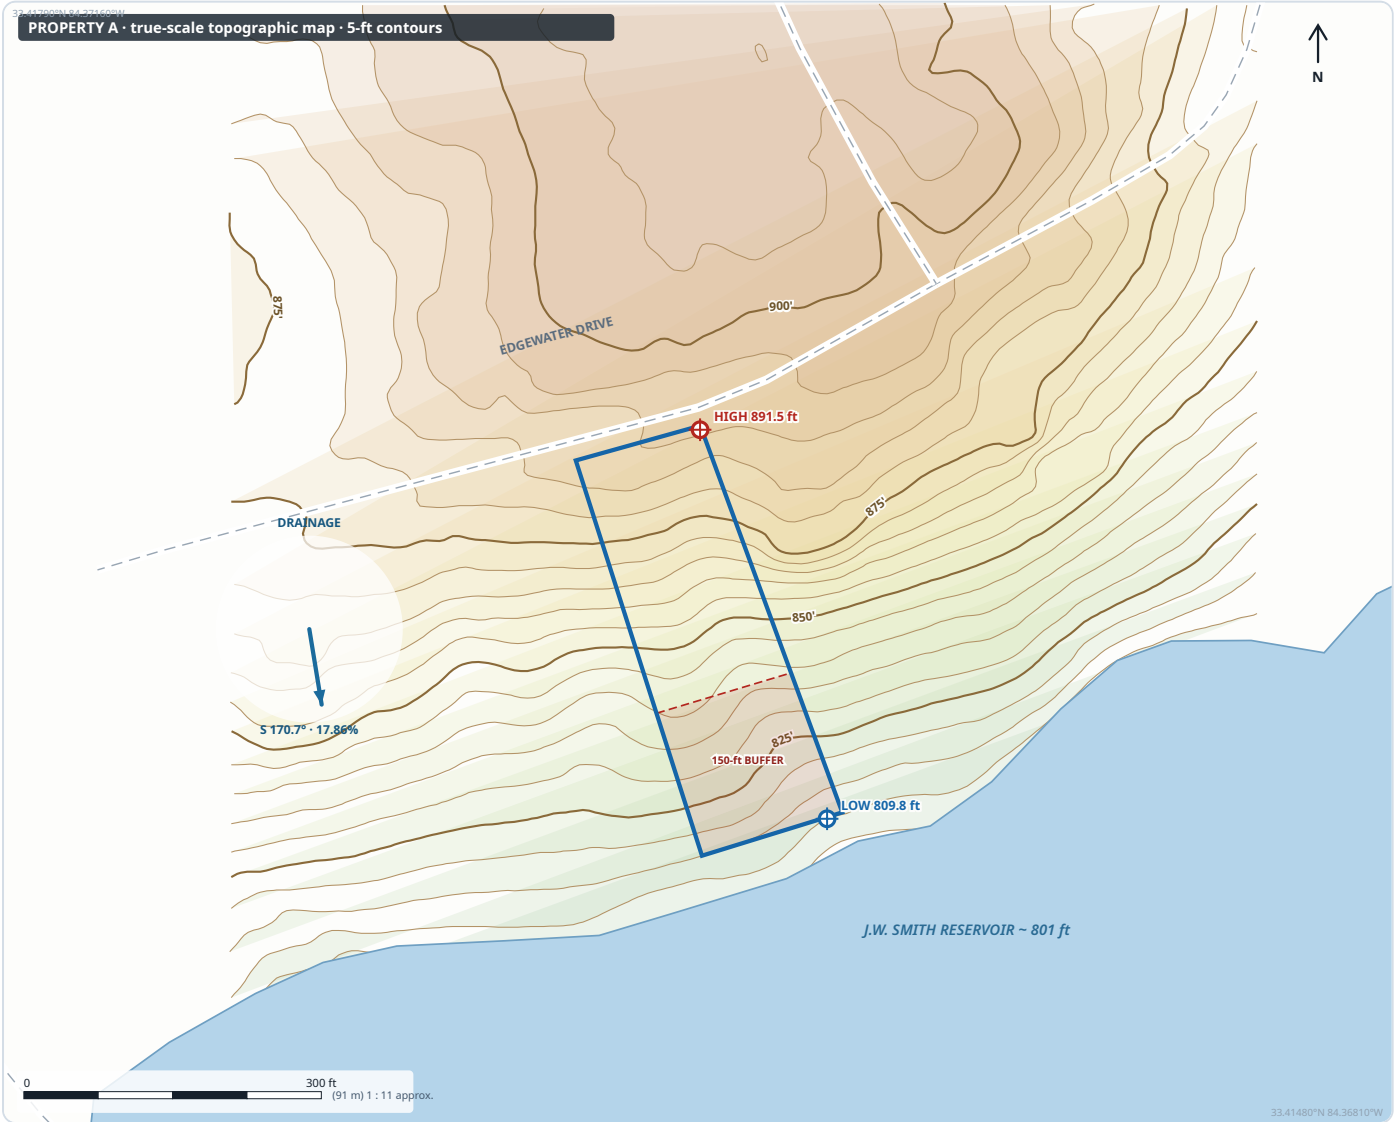
Figure B-1 — Property A: true-scale topographic map. North up, with graphic scale bar and north arrow. Contours at the selected interval, derived from the 1-metre lidar DEM and lightly smoothed (5-cell mean) to suppress canopy noise. GIS-DERIVED
The lot falls **continuously and steeply from Edgewater Drive at ~892 ft to the reservoir edge at ~801 ft**. Contours are tightly spaced through the upper and middle thirds — the signature of a sustained slope, not rolling ground. Drainage is **due south (bearing 170.7°)** straight into the reservoir, at a mean grade of 17.9%.

HIGHEST POINT ON LOT 891.5 ft — at the road, 33.41672, -84.36984	LOWEST POINT ON LOT 809.8 ft — rear/east, 33.41564, -84.36942	RELIEF ACROSS LOT 81.7 ft of fall	MEAN / MEDIAN ELEVATION 850.0 ft (median 847.1)	WATER SURFACE (LIDAR) 801.2 ft — reservoir
--	---	--	---	---

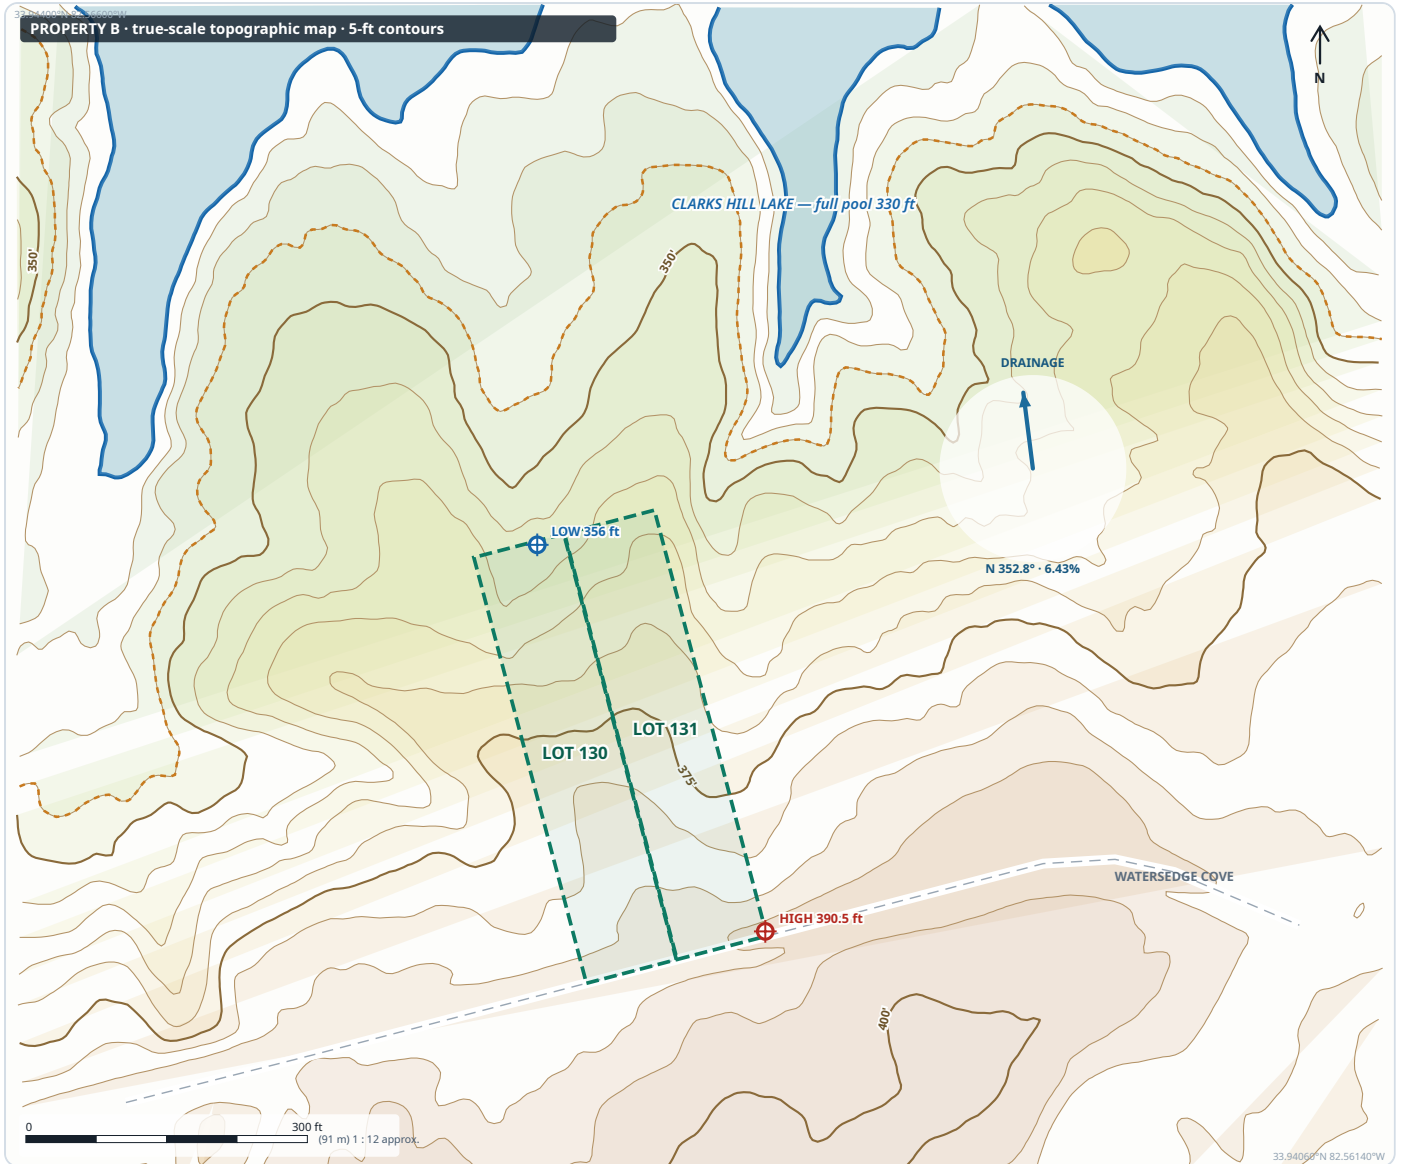
Figure B-2 — Property B: true-scale topographic map. North up. GIS-DERIVED LOT OUTLINE RECONSTRUCTED

The contrast with Figure B-1 is immediate: contours across the reconstructed lot are **widely spaced** — this is gentle ground. The tight contour bunching lies **beyond** the rear lot line, on the federal strip descending to the water. **The bold dashed line is the 330-ft full pool; the dotted line is the 346-ft elevation defining the USACE purchase boundary.** Both lie outside the reconstructed lot. Drainage is **due north (352.8°)** toward the lake at a mean grade of 6.4%.

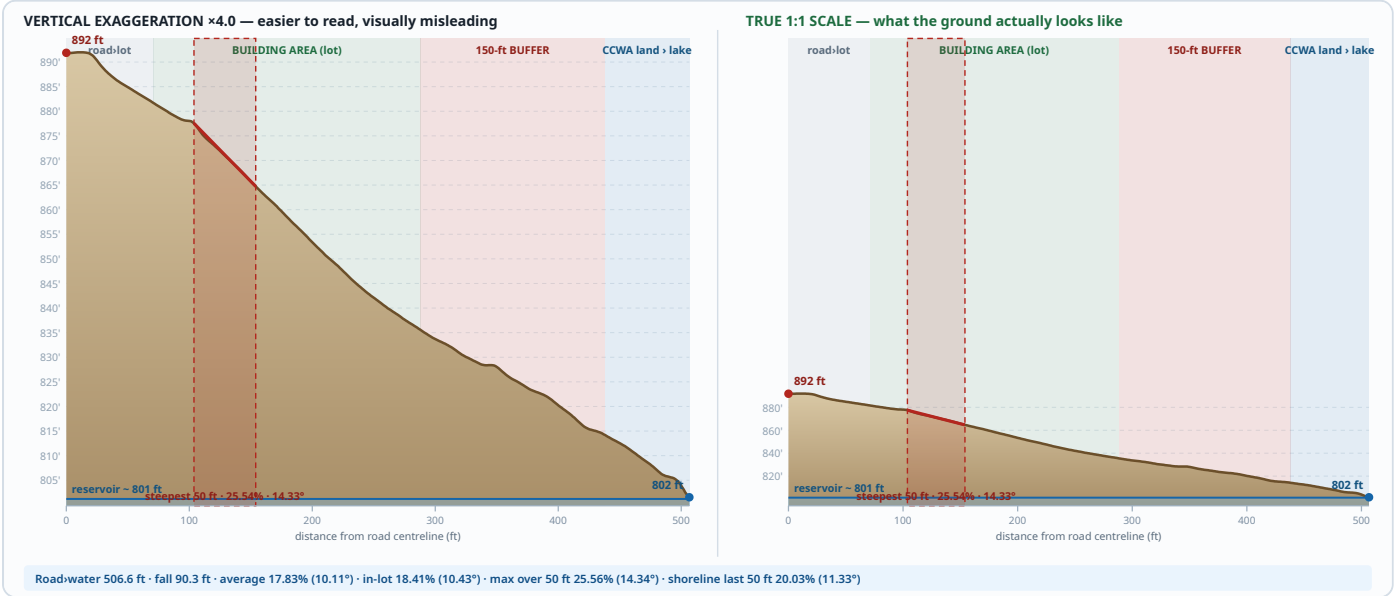
Figure B-3 — Property A: road-to-lake longitudinal section. Left panel exaggerated as selected; right panel at true 1:1 scale. The section runs from the Edgewater Drive centreline, through the front of the lot, the prospective building area, the rear of the lot and the 150-ft reservoir buffer, to the water's edge. GIS-DERIVED

The profile is **concave-upward and sustained** — it steepens immediately below the road, holds 18–25% through the upper half, then eases slightly before a renewed 20% pitch at the shoreline. There is **no natural bench or flat building pad anywhere on this lot.**

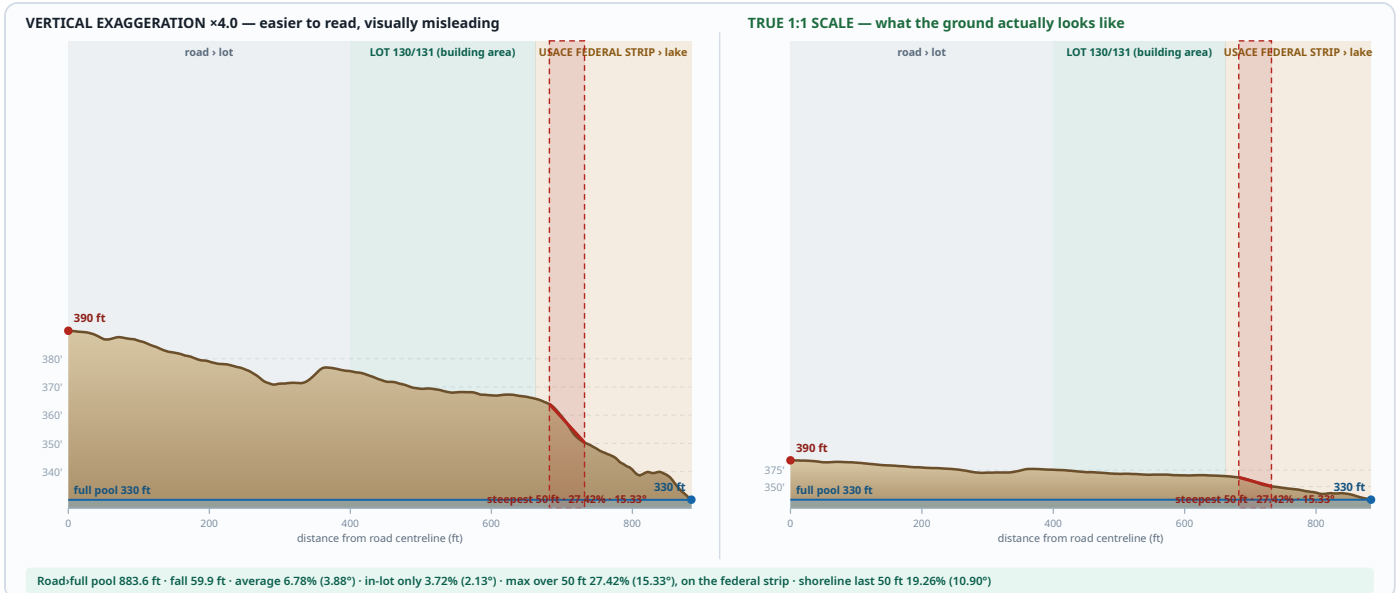
Figure B-4 — Property B: road-to-lake longitudinal section. Left panel exaggerated as selected; **right panel at true 1:1 scale.** The section runs from the Watersedge Cove centreline on bearing 42.5° — the bearing that reaches full-pool water soonest — through the reconstructed lot and across the federal strip to the 330-ft shoreline. **GIS-DERIVED**

The shape of this profile is the **opposite** of Property A's: a long, almost level upper reach across the buildable ground, then **all of the fall concentrated in the final ~220 ft** beyond the rear lot line. At 1:1 the lot itself looks genuinely flat — because it very nearly is.
