AROD oxygen sensors deterioration of foils

Tuesday, 27 June 2023 14:44

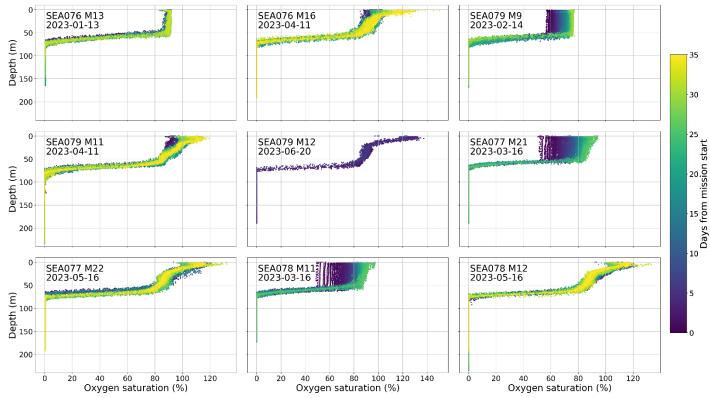
Few example missions from the Gotland Basin are shown below (Figure 1). Oxygen saturation over depth is presented and data is colored by time (in days since deployment). Some missions exhibit an evident temporal drift (SEA079_M9; SEA077_M21; SEA078_M11) with saturation values increasing from around 50% to just below 100% in about 25 days.

Figure 1: Oxygen saturation plotted over depth and colored by time (in days since deployment) for 9 missions in the Gotland Basin. Glider serial and mission number as well as the deployment date are noted on the top left of each subplot.
