Quality Issue #001: RINKO-AROD-FT optodes

Issue number: 1					
Contact details: chiara.monforte@voiceoftheocean.org; callum.rollo@voiceoftheocean.org					
Version	Date	Comments	Authors		
1	2023-07-07	Creation of document	Chiara Monforte and Callum Rollo

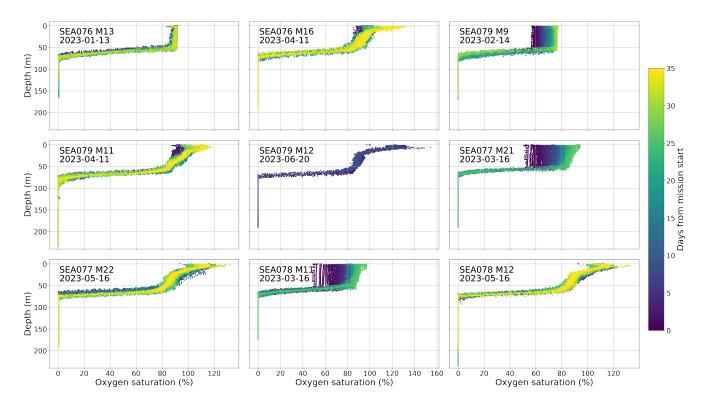
Few example missions from the Gotland Basin are shown below (Figure 1). Oxygen saturation over depth is presented and data is colored by time (in days since deployment). Some missions exhibit an evident temporal drift (SEA079_M9; SEA077_M21; SEA078_M11) with saturation values increasing from around 50% to just below 100% in about 25 days.

Figure 1: Oxygen saturation plotted over depth and colored by time (in days since deployment) for 9 missions in the Gotland Basin. Glider serial and mission number as well as the deployment date are noted on the top left of each subplot.
