Test Report

Ballistic Resistance Test

Bullet Proof Sliding Gate (Main Gate)

JODDB/TEST/BTF/TR/1089

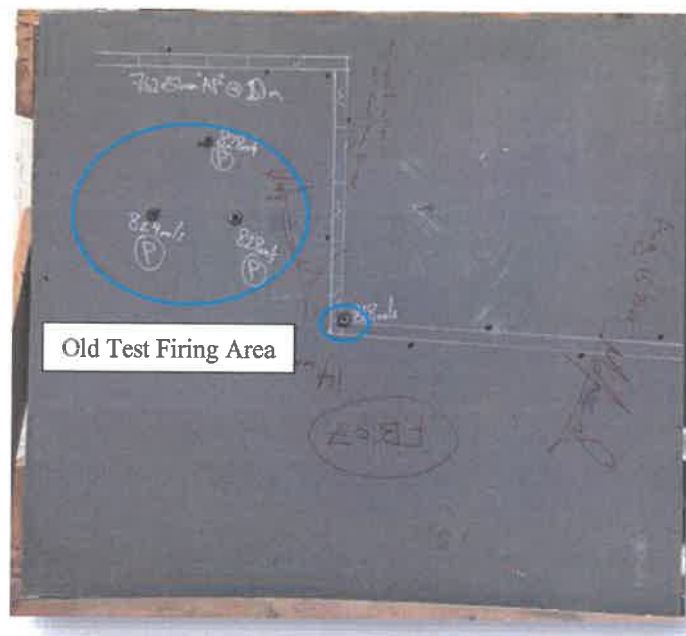
Photo No. 1: Test Sample (Before Firing)

Bullet Proof Sliding Gate (Main Gate) Drawing No. SSW-002 Dated 17 July 2022

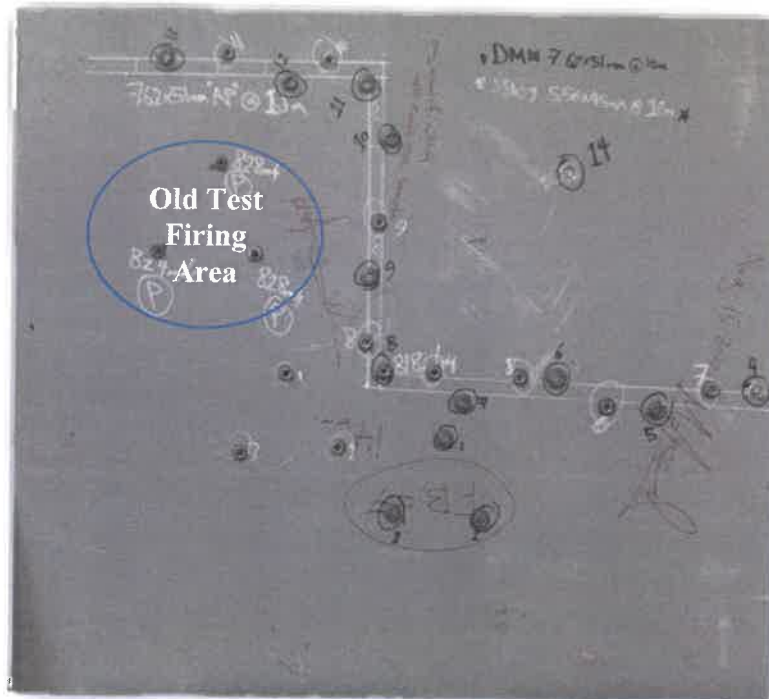
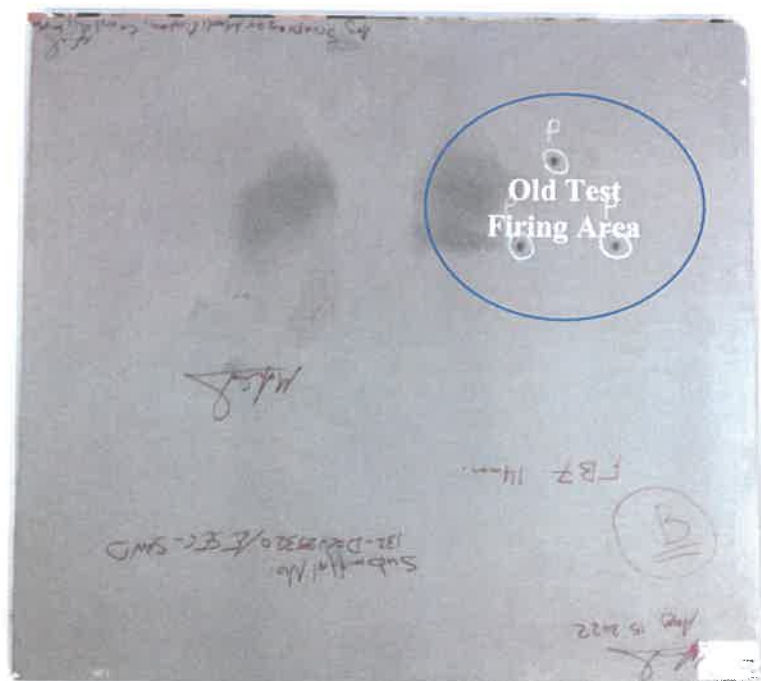
5.56x45mm "SS 109" Bullet Velocity (950 ±10)m/s @ 7.5m	1	941.5	0	NS
	2	944.1	0	NS
	3	946.0	0	NS
	4	940.3	0	NS
	5	941.2	0	NS
	6	952.8	0	NS
	7	952.3	0	NS
	8	944.7	0	NS
	9	945.6	0	NS
	10	949.3	0	NS
	11	948.5	0	NS
NS-No perforation & No Splinters. See photos No.4				
Status: Comply				
EN1522/1523 Performance Requirements P - Perforation: Piercing of a test piece by a bullet or by bullet fragments, and/or creation of an opening from the attack face to the rear face The following are considered to constitute perforation: a) passing through the test specimen by the bullet or any part of it; b) splitting of the rear surface of the test specimen by the bullet or part of it, even if the bullet is visibly retained in the rear of the test specimen; c) Creation of an opening right through the specimen, even if that opening closes again afterwards. S - No Perforation with Splinters: No perforation of the test piece by the bullet or parts of the bullet. But with perforation of the witness foil by glass splinters from the protected face. NS - No Perforation & No Splinters: No perforation of the test piece by the bullet or parts of the bullet. And no perforation of the witness foil by glass splinters from rear face.

Photos No. 2: Status of Bullet Proof Sliding Gate (Main Gate) after firing 7.62x51mm NATO Ball "DM111" & 5.56x45mm "SS109" rounds from 10 m.

Bullet Proof Sliding Gate (Main Gate) (No Penetration)
Impact Side

Back Side
