Issues with Atmoscan 1.0

Modifications in version 2

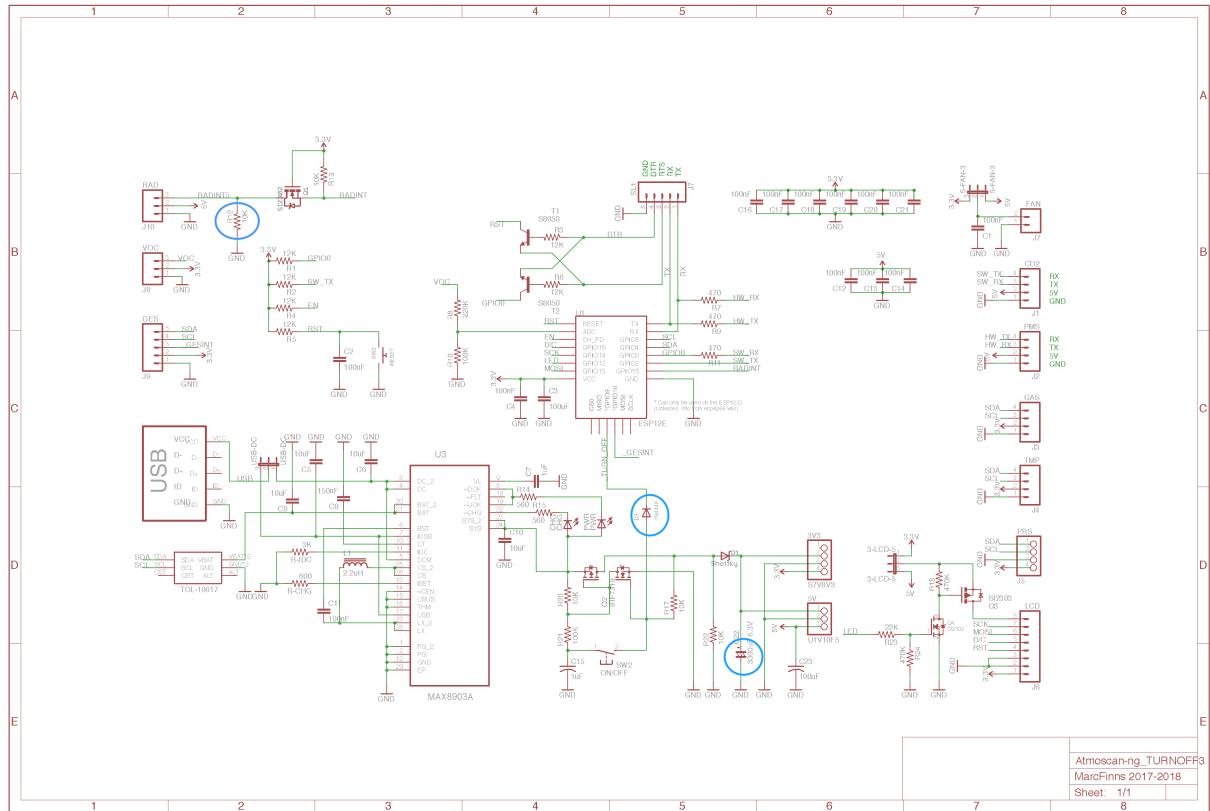
1. The board would not boot when the radiation board is disconnected, unless the input line is pulled low
2. Copper ground plane is present in the PCB v1 behind the ESP12 antenna, making the antenna radiation pattern non omnidirectional
3. The system could not be turned off the system via software. Gracefully handling the low battery situation was not possible
4. A white screen issue that sometimes appears when battery was almost depleted.
After extensive investigation, this issue was tracked down to the CO2 sensor that draws significant current spikes from the 5V line every 5 seconds. When the battery is low, these are sufficient to affect even the 3.3V regulator.

1. A pull-down resistor to allow boot without radiation sensor
2. Ground plane is selectively removed in the antenna area
3. A diode is added to trigger the switch off via GPIO
4. A large capacitor (3300uF, 6.3V) is added on the unregulated voltage line
