Institute for Science and International Security

Damage at the Natanz Uranium Enrichment Plant

By David Albright, Sarah Burkhard, Spencer Faragasso, and the Good ISIS Team

March 3, 2026

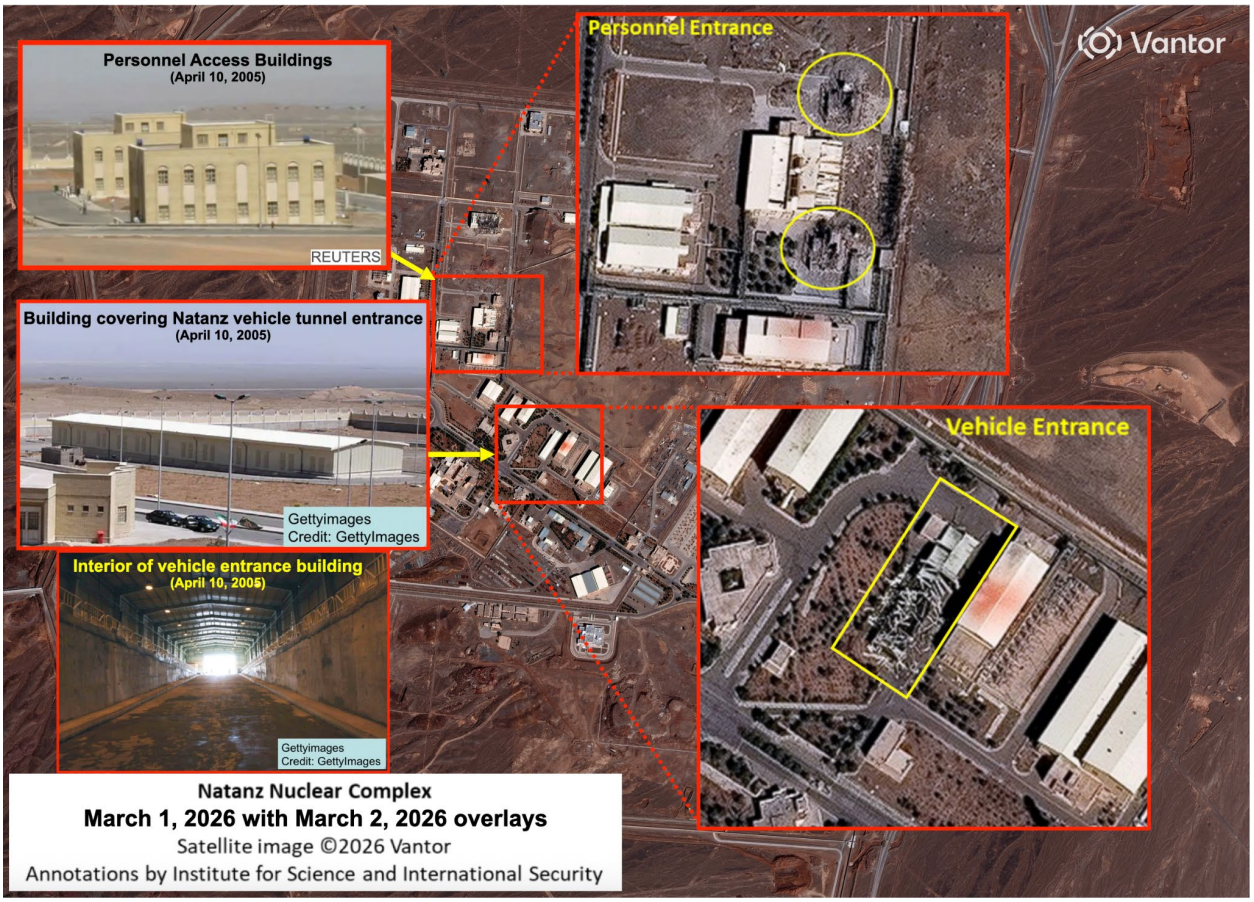
The images dated March 2, 2026, show that personnel entrances and the sole vehicle entrance to the non-operational, underground Natanz enrichment plant were targeted. Damage to the facility was further confirmed by the IAEA on March 3rd.[4]

Figure 1 shows the severe damage to the two personnel entrance buildings, as well as the damage to a building covering the vehicle entrance ramp. It includes ground images of the two, 3-story, identical personnel entrance buildings, in addition to the building covering the vehicle access ramp with an inside view from the vehicle access ramp.

Figure 1. High resolution imagery taken on March 2 shows the damaged personnel and vehicle entrance buildings and ground photos of what they looked like before the attack.

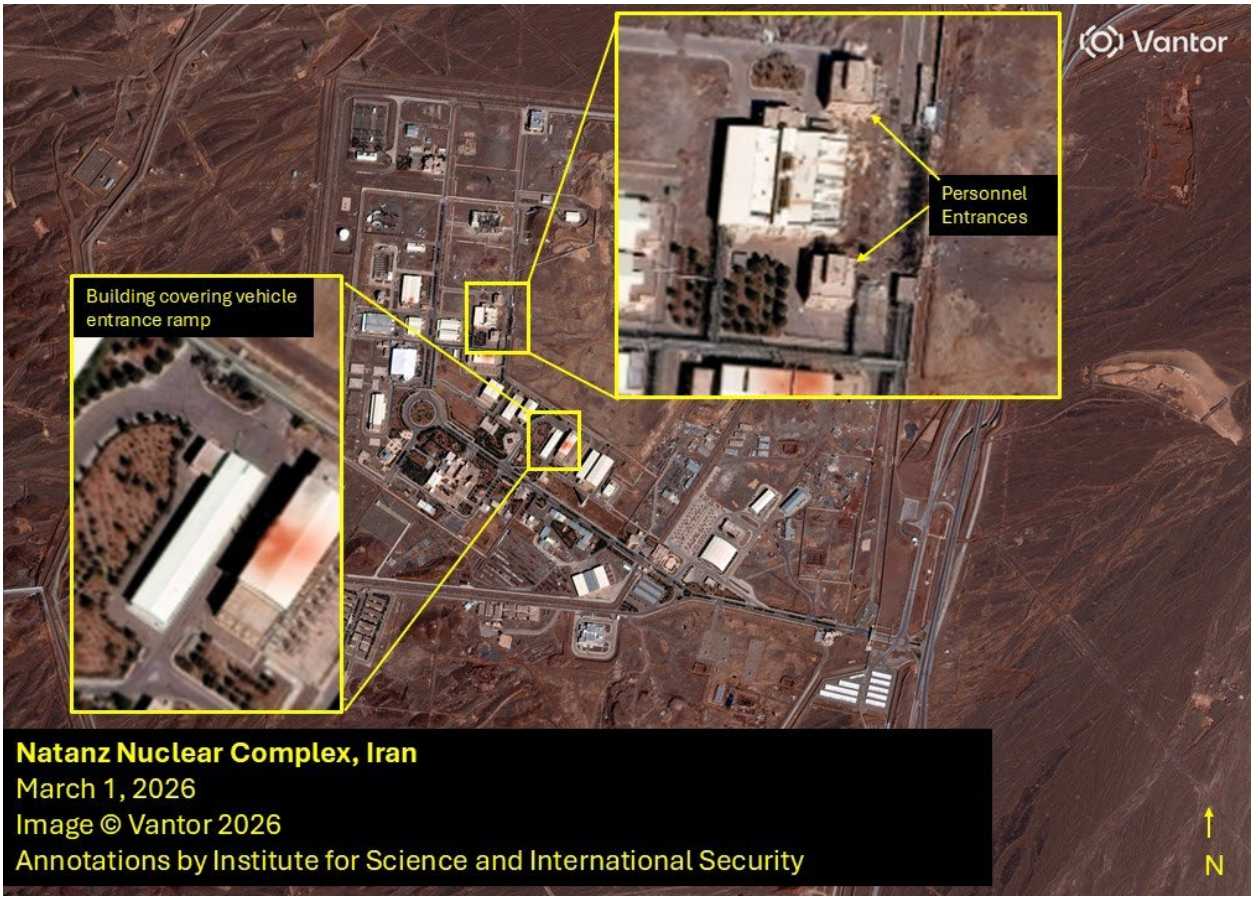
Figure 2 shows the buildings before the attack, in the morning of March 1, for comparison.

Figure 2. A satellite image taken shortly before the strikes on March 1.

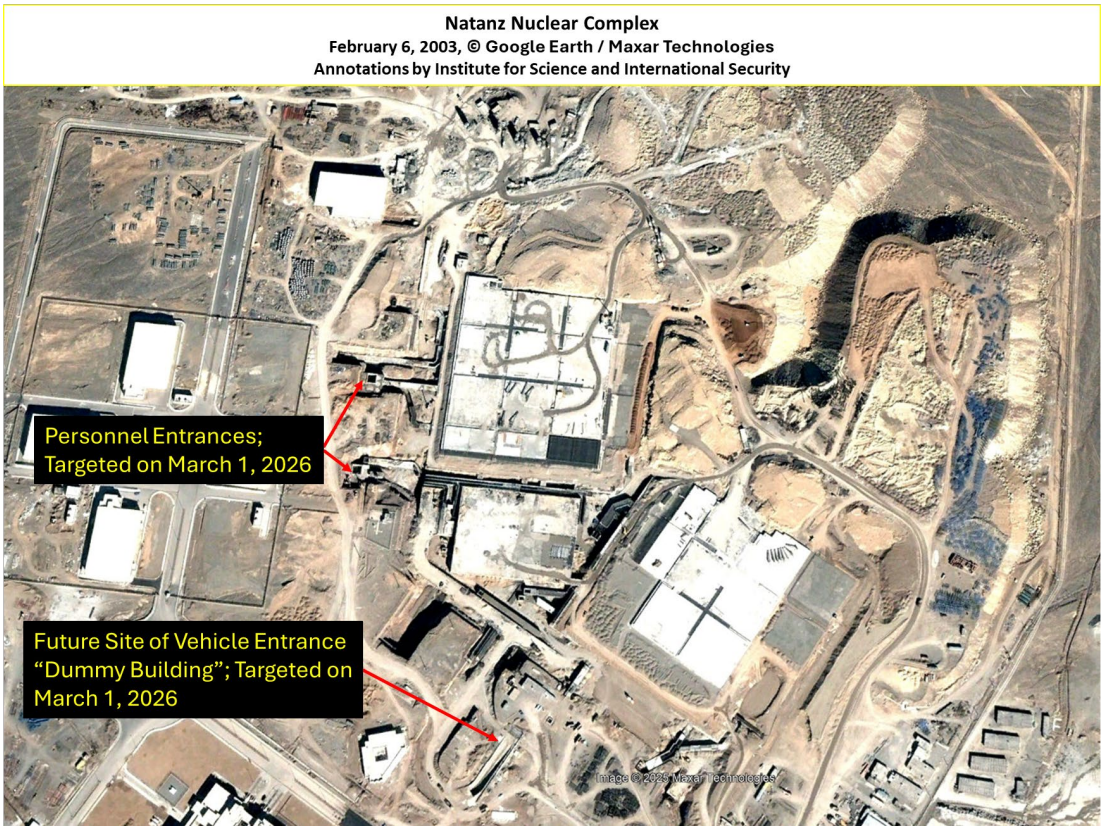
Figure 3 shows the entrances under construction in 2003 and their location vis a vis the underground enrichment halls.

Figure 3. The entrances can be seen under construction in 2003, showing their location vis a vis the large underground enrichment halls, which were still being buried with layers of rock and cement.
