## FIELD SERVICE BULLETIN

DATE ISSUED: 8/27/09 NUMBER: 585

## **Chameleon Vision Sealed Cavity**

**PRODUCT** All Chameleon Vision systems

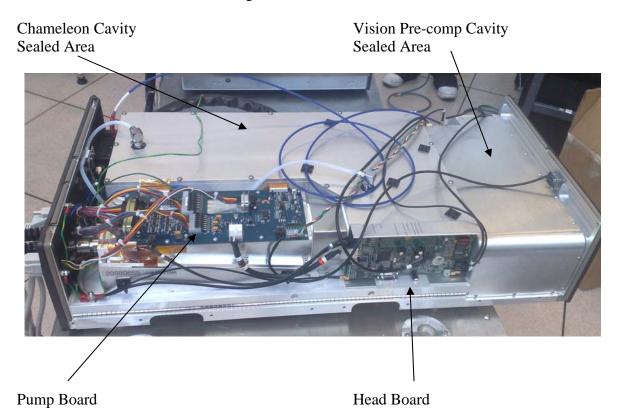
Fig 2 – Internal covers

hermetically sealed in the clean-room and should never be opened in the field. Opening the cavity or pre-comp section will result in contamination and necessitate a major repair with mechanical strip-down for complete re-cleaning. The outer-lid can be removed to gain access to the Chameleon headboard and Verdi pump-board as shown in Fig1. The internal covers should never

be removed as highlighted in Fig2.
