Technical Information

TECHNICS CD

MAY 1987

MODELS: SL-P520, SL-P720

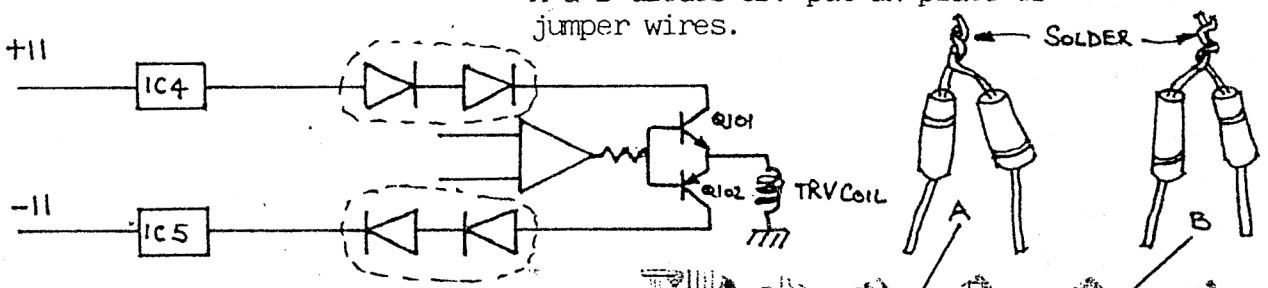
SYMPTOMS: No operations or the unit reads TOC but fails to enter into play mode.

CAUSE: When spindle drive IC is overheated and locked up while subjected to excessive vibration; excessive use of cue/review, and set switched on and put in play with transit clip left on; IC4 AND IC5 overheats and internal IC fuses go open.

Thermal runaway also causes transistors Q11, Q12, Q101 and Q102 to go short, and heat often causes these transistor legs solder to give dry joint.

METHOD: (1) Replace Q11 and Q101 by 2SC1846
Q12 and Q102 by 2SA885
New transistors are larger and have to be fitted as shown.

(2) Add 4 diodes in series with connectors of transistors to reduce the voltage as shown.
