Technical Information

MAY 1987

MODELS: SL-P520, SL-P720

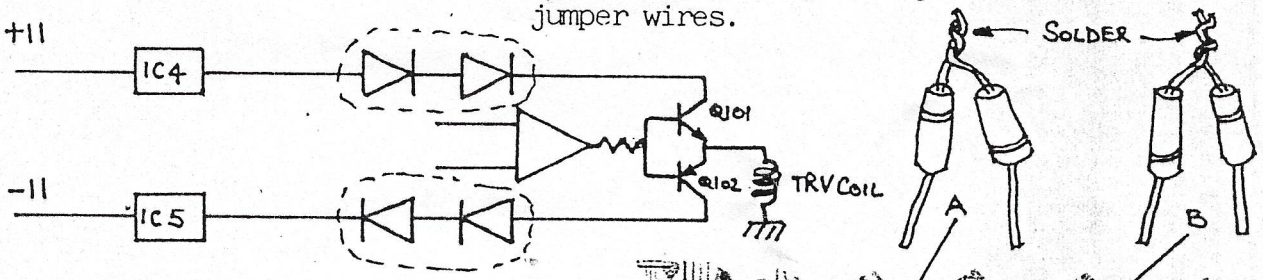
CAUSE: When spindle drive IC is overheated and locked up while subjected to excessive vibration; excessive use of cue/review, and set switched on and put in play with transit clip left on; IC4 AND IC5 overheats and internal IC fuses go open.

Thermal runaway also causes transistors Q11, Q12, Q101 and Q102 to go short, and heat often causes these transistor legs solder to give dry joint.

METHOD: (1) Replace Q11 and Q101 by 2SC1846
Q12 and Q102 by 2SA885
New transistors are larger and have to be fitted as shown.

(2) Add 4 diodes in series with connectors of transistors to reduce the voltage as shown.

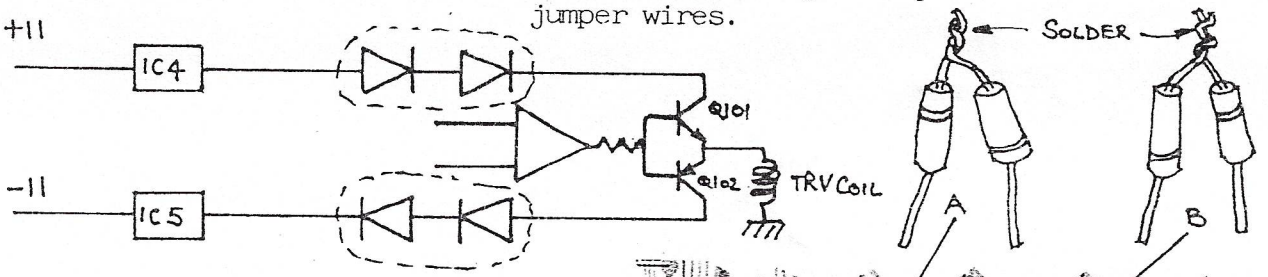
CAUSE: When spindle drive IC is overheated and locked up while subjected to excessive vibration; excessive use of cue/review, and set switched on and put in play with transit clip left on; IC4 AND IC5 overheats and internal IC fuses go open.

Thermal runaway also causes transistors Q11, Q12, Q101 and Q102 to go short, and heat often causes these transistor legs solder to give dry joint.

METHOD: (1) Replace Q11 and Q101 by 2SC1846
Q12 and Q102 by 2SA885
New transistors are larger and have to be fitted as shown.

(2) Add 4 diodes in series with connectors of transistors to reduce the voltage as shown.

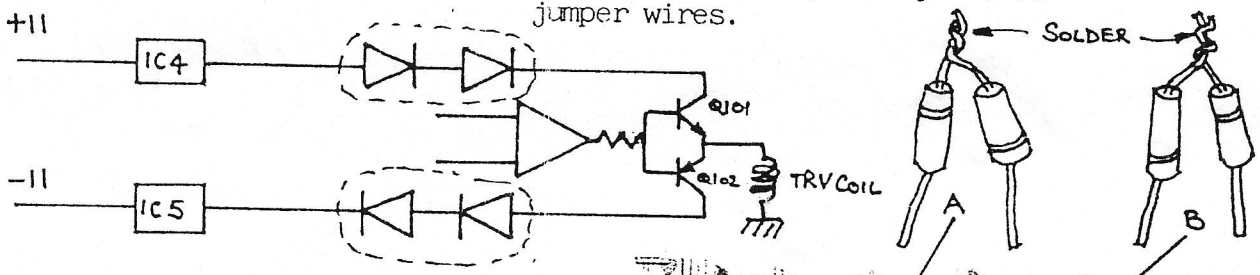
CAUSE: When spindle drive IC is overheated and locked up while subjected to excessive vibration; excessive use of cue/review, and set switched on and put in play with transit clip left on; IC4 AND IC5 overheats and internal IC fuses go open.

Thermal runaway also causes transistors Q11, Q12, Q101 and Q102 to go short, and heat often causes these transistor legs solder to give dry joint.

METHOD: (1) Replace Q11 and Q101 by 2SC1846
Q12 and Q102 by 2SA885
New transistors are larger and have to be fitted as shown.

(2) Add 4 diodes in series with connectors of transistors to reduce the voltage as shown.
