SME10756 — Brook Park Imaging Center MRI

Network Imaging Associates LLC · Siemens MRI · Brook Park, OH · Jul 7 – Aug 6 monitor data (1,478 captures)

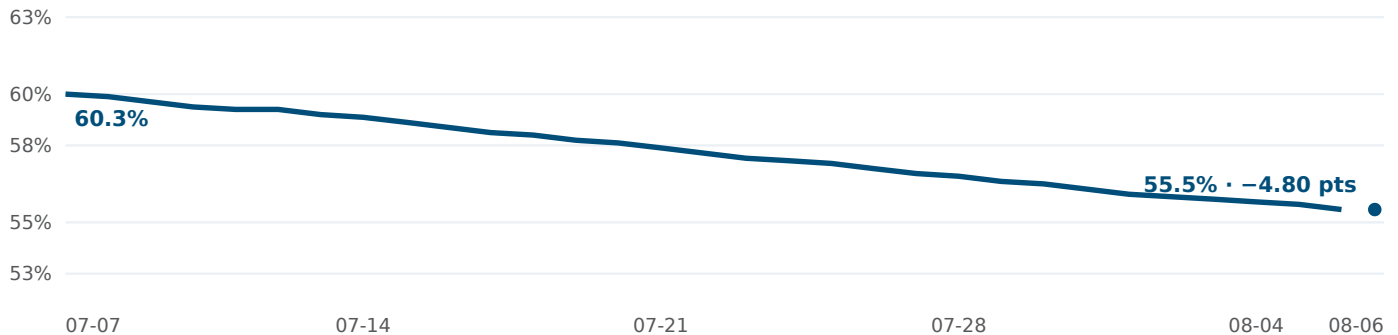
SHIELD TEMP — JUL 7 → AUG 6 (daily range, K)

Timeline (UTC): No compressor events, alarms, or threshold breaches detected across 1,478 captures. The compressor signal dropped for a single reading 3 times (Jul 21 17:45Z, Jul 24 16:45Z, Jul 27 15:45Z) with no shield temp response — **likely sensor flickers, not true stops**. Helium fell to **55.5%** (–4.80 vs baseline). No quench. Shield temp now reads 52.0 K (Aug 6 18:45Z) — 52% of the line.

Shield temp +3.0 K vs baseline (49.0 → 52.0); peak 52.0. Helium –4.80 points.
