HQDFM Design for Manufacture(DFM) Report

File name: 2026-09-14

Time: 2026-09-14Layer count:2PCB Thickness: 1.60Quantity: 5mm

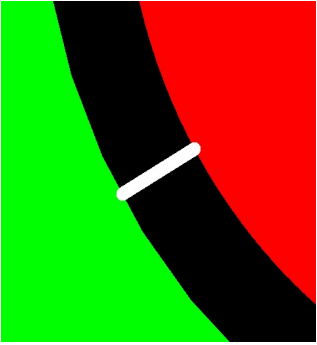
ID	Check	Limits	Value	Issue	Image	Position	Qty	Level
1	Drill to Copper_NPTH-to-Copper	8,10,12	0.25 mm	NPTH to copper spacing of 9.86mil was detected in your design. This could increase the risk of defects such as short circuits, which decrease manufacturing efficiency and yield, and affect the reliability of the boards. It is recommended to increase the spacing to at least 12 mil.		185.51,-209.86	36	Warning
