# Pure loss of stability in stern quartering waves: revisited with numerical simulations reproducing accidents

Naoya Umeda, Osaka University, umeda@naoe.eng.osaka-u.ac.jp
Mizuki Osugi, Osaka University, Haruka Nagato, Osaka University,
Yuito Ikenaga, Osaka University, Kazuma Matsubara, Osaka University,
Atsuo Maki, Osaka University and
Akihiko Matsuda, National Research Institute of Fisheries Engineering

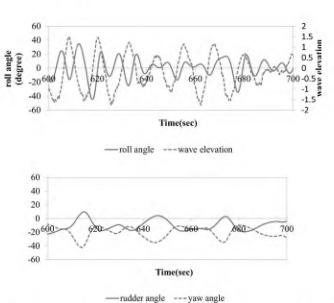
Figure 5: Numerical simulation of the ocean research vessel with the restoring variation.

For investigating the reason why large roll occurs, comparative simulations were executed. Firstly, the time series of numerical simulation with and without the roll restoring variation for a typical case are shown in Figures 5 and 6, respectively. Here the wave elevation indicates its value at the midship and its minima correspond to a wave crest. The positive roll angle means the starboard downwards, the positive yaw angle does the starboard turn and the positive rudder angle normally induces the starboard turn. As shown in Figure 5, a large roll angle of about 35 degrees towards port side occurs shortly after the wave crest amidship. This seems to be relevant to a pure loss of stability. However, it is noteworthy here that at the moment the yaw rate towards starboard side becomes very large. It could induce large centrifugal force due to this large yaw rate, which could result in large heel towards the port side. Indeed, the numerical simulation without the restoring variation, as shown in Figure 6, shows that

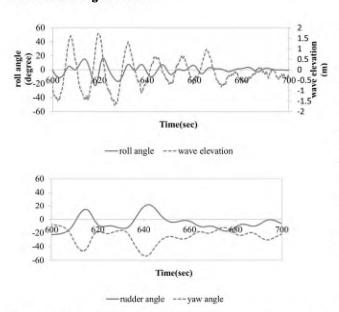
Figure 6: Numerical simulation of the ocean research vessel without the restoring variation.

slightly smaller but still more than 20 degrees roll occurs at the relevant moment. Therefore, we should conclude the roll restoring variation is not the only reason of large roll.

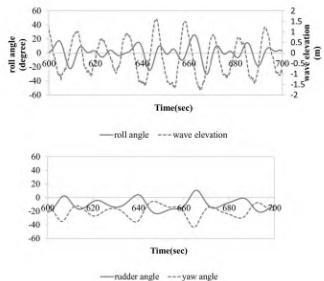
Figure 7: Numerical simulation of the ocean research vessel without the roll damping components due to sway velocity and yaw angular velocity.

For more directly confirming the reason of large heel, the numerical simulation without roll damping components due to sway velocity and yaw angular velocity was executed as shown in Figure 7. This indicates that the roll angle becomes further reduced from about 35 degrees to about 7 degrees. Thus, we can conclude that the coupling between sway/yaw and roll is also a major reason of the large heel at the wave crest amidship. Therefore, we can presume that

both roll restoring variation and the roll-sway/yaw coupling are important for large heels in stern quartering waves.

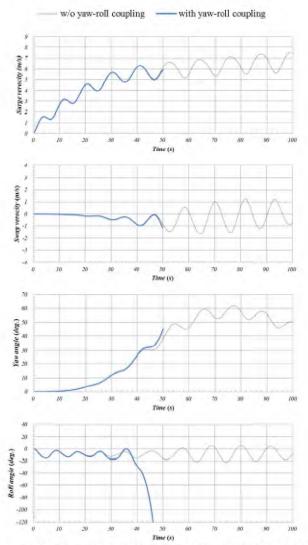
Figure 8: Numerical simulation of the torpedo boat with and without yaw-roll coupling. Here the wave steepness of 0.06, the wavelength to ship length ratio of 1.0, the Froude number of 0.26 and the heading angle of 50 degrees from the wave direction.

The simulated result with yaw-roll coupling demonstrates that the ship rapidly turns to starboard side and then capsizes to port side. This is the same as the accident report (Matsumoto, 1954). On the other hand, the ship does not capsize if we ignore yaw-roll coupling in the numerical model.

Therefore, we presume that the reason of capsizing could be considered yaw-roll coupling.
