Newsletter195

Keith's Corner/McGill News

February 3, 2023

Update on The Drugstore

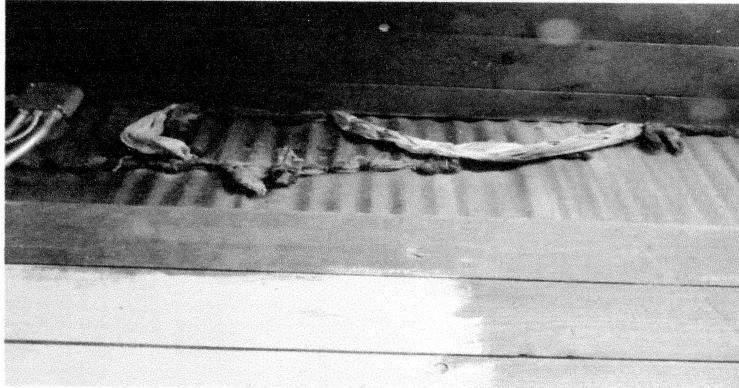
Wall near the ceiling in the NW storage room, showing the original tin siding. This room was added on in the late 29s or early 30s. The wood was used to cover the tin but not all the way to the top. The seam in the tin was stuffed with cotton and rags.

Upon pulling the rags and cotton out, a lot of dirt and cold air came flowing out.

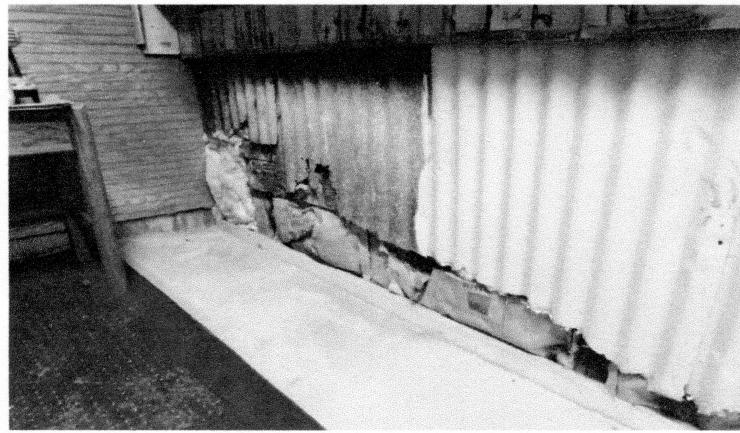
When we moved a makeshift set of shelves in the NE storeroom, I found this mess. The cold air poured into the room along with a lot of dirt. No

wonder that room was always so cold.

We cleaned the area up and then stuffed insulation in all the spaces and cracks.
