Limited Hazardous Materials Survey Report

Pierce County- County City Building 1st Floor Door Widening
930 Tacoma Avenue South,
Tacoma, Washington 98402

April 25, 2025
PBS Project PIE019-25006863

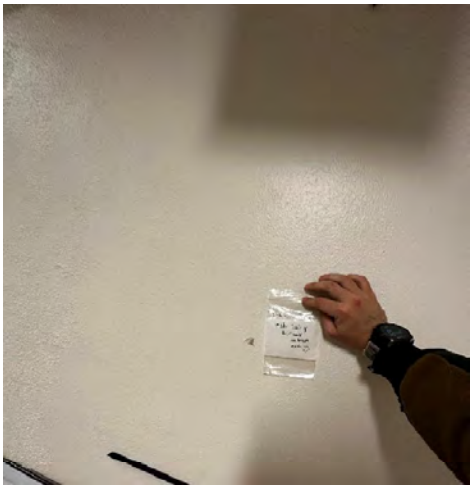
Sample Number(s): CBM1-01

Asbestos Content: NAD

Description: 4" Black Cove Base with Tan mastic

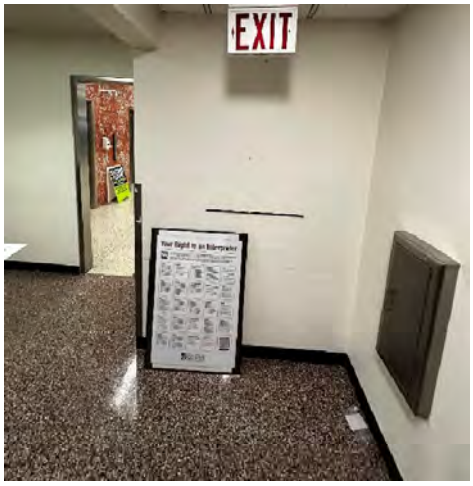
Sample Number(s): OTH2-1, OTH2-02

Asbestos Content: NAD

Description: Terrazzo Flooring

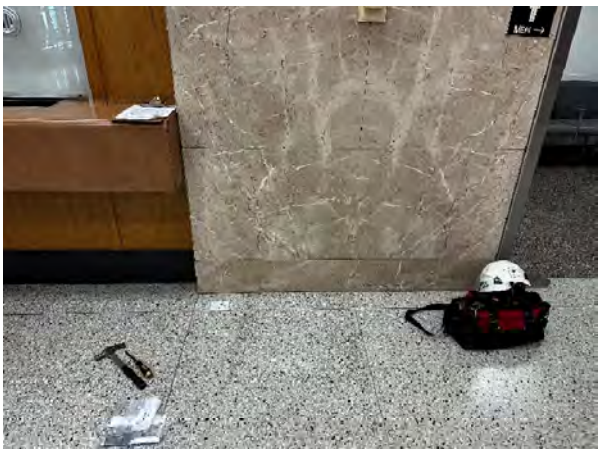
Sample Number(s): OTH3-01

Asbestos Content: NAD

Description: Red Speckled Thin Stone Tile with Grout
