QA DISPOSITION REPORT burn-in parametric screening

Component	LOT213-C0256	Lot	LOT213	Board	LOT213-B04
Socket	r0 c0	Generated	2026-09-29 11:13		
Model version	dataset-v1.2 / a1d6a8e / ModuleB 0-24h

DECISION: FIXTURE SUSPECT

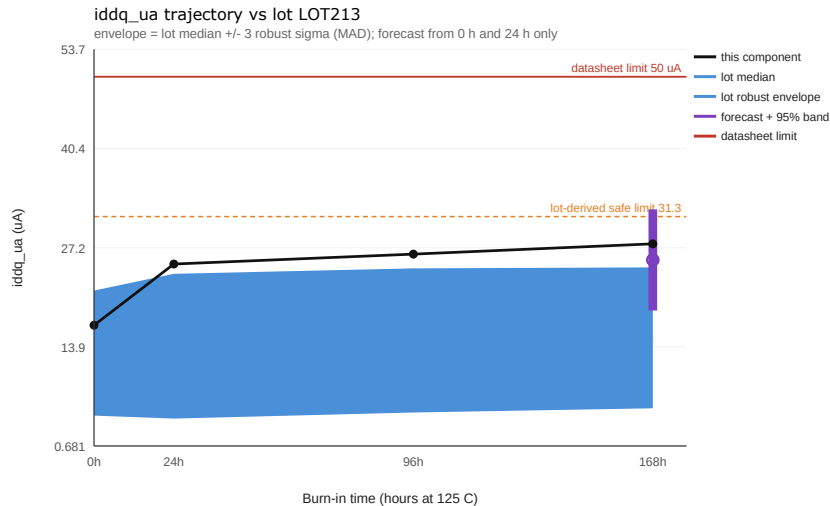
LAYER 1 — deterministic evidence (every value cites its comparison basis)

Absolute limit	PASS (54.90 mA vs 65.0 mA max, supply_current_ma)
Lot-relative level	+4.5 robust sigma vs lot median on leakage_na (median 31.69 nA, sigma 7.40 nA, n=496, MAD estimator; AEC-Q001 IQR/1.35 gives 7.43 nA)
Drift 0h to 24h	+8.174 uA (+48.6%) on iddq_ua; lot median drift +0.584 uA (+4.5%), part is +12.3 robust sigma on the lot's drift distribution
Drift rate	0.3406 uA/h (lot median 0.0243 uA/h, 14.0x)
Max interval jump	+16.5 robust sigma on iddq_ua; largest interval change is 6.0x the median of the others (concentrated -> step)
Predicted 168h	25.526 uA (iddq_ua, from 0h and 24h only)
95% upper bound	32.283 uA -> EXCEEDS lot-derived safe limit 31.321 uA
Joint anomaly	Mahalanobis D2 = 41.2 (good-part 99th pct = 19.2); largest contribution leakage_na at 62% of the total
Leakage/delay sign	leakage +4.5 sigma, delay -0.6 sigma -- consistent with the lot's process locus
Spatial check	52 of 64 components on board LOT213-B04 flagged (expected 1.7, p=3.0e-70); shift since 0 h: leakage +2.1, delay +0.4, vth -1.7 sigma -- THERMAL signature, suspect fixture

Data quality	all checkpoints valid
Primary reason	anomaly clusters by board position, not by component
Secondary	discrete step between checkpoints
Action	Do NOT reject the component on this evidence. Raise a fixture/chamber investigation for the affected board and re-test these positions in a different socket.

chamber thermal gradient or socket contact degradation [confidence: well-founded]
Because: 52 flagged components share board LOT213-B04, and the leakage/delay shift has the thermal sign (leaky and slow) rather than the process sign
Caveat: Same sign argument, used the other way. HEAT raises leakage and SLOWS the part; the process corner makes leaky parts FAST. So a fixture artifact and a process outlier push the leakage/delay correlation in OPPOSITE directions and are separable by the sign of the shift, before any spatial evidence is considered. The board clustering is then confirmatory rather than the sole basis.
Suggested next test: map the chamber with a calibrated thermocouple board; re-test the affected positions in a different socket
