QA DISPOSITION REPORT burn-in parametric screening

Component	LOT213-C0256	Lot	LOT213	Board	LOT213-B04
Socket	r0 c0	Generated	2026-09-29 11:36		
Model version	dataset-v1.2 / 2eeee48 / ModuleB 0-24h

DECISION: FIXTURE SUSPECT

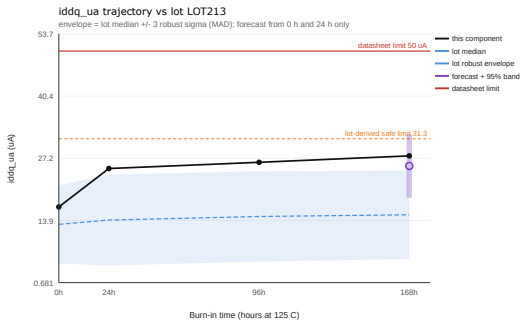
Absolute limit	PASS (54.90 mA vs 65.0 mA max, supply_current_ma)
Lot-relative level	+4.5 robust sigma vs lot median on leakage_na (median 31.69 nA, sigma 7.40 nA, n=496, MAD estimator; AEC-Q001 IQR/1.35 gives 7.43 nA)
Drift 0h to 24h	+8.174 uA (+48.6%) on iddq_ua; lot median drift +0.584 uA (+4.5%), part is +12.3 robust sigma on the lot's drift distribution
Drift rate	0.3406 uA/h (lot median 0.0243 uA/h, 14.0x)
Max interval jump	+16.5 robust sigma on iddq_ua; largest interval change is 6.0x the median of the others (concentrated -> step)
Predicted 168h	25.526 uA (iddq_ua, from 0h and 24h only)
95% upper bound	32.283 uA -> EXCEEDS lot-derived safe limit 31.321 uA
Joint anomaly	Mahalanobis D2 = 41.2 (good-part 99th pct = 19.2); largest contribution leakage_na at 62% of the total
Leakage/delay sign	leakage +4.5 sigma, delay -0.6 sigma -- consistent with the lot's process locus
Spatial check	52 of 64 components on board LOT213-B04 flagged (expected 1.7, p=3.0e-70); shift since 0 h: leakage +2.1, delay +0.4, vth -1.7 sigma -- THERMAL signature, suspect fixture

Data quality	all checkpoints valid
Primary reason	anomaly clusters by board position, not by component
Secondary	discrete step between checkpoints
Action	Do NOT reject the component on this evidence. Raise a fixture/chamber investigation for the affected board and re-test these positions in a different socket.

chamber thermal gradient or socket contact degradation [confidence: well-founded]
Because: 52 flagged components share board LOT213-B04, and the leakage/delay shift has the thermal sign (leaky and slow) rather than the process sign
Caveat: Same sign argument, used the other way. HEAT raises leakage and SLOWS the part; the process corner makes leaky parts FAST. So a fixture artifact and a process outlier push the leakage/delay correlation in OPPOSITE directions and are separable by the sign of the shift, before any spatial evidence is considered. The board clustering is then confirmatory rather than the sole basis.
Suggested next test: map the chamber with a calibrated thermocouple board; re-test the affected positions in a different socket
