QA DISPOSITION REPORT burn-in parametric screening

Component	LOT213-C0256	Lot	LOT213	Board	LOT213-B04
Socket	r0 c0	Model version	dataset-v1.1 / ModuleA-d13e1f1 / ModuleB-2606082710:40

DECISION: FIXTURE SUSPECT

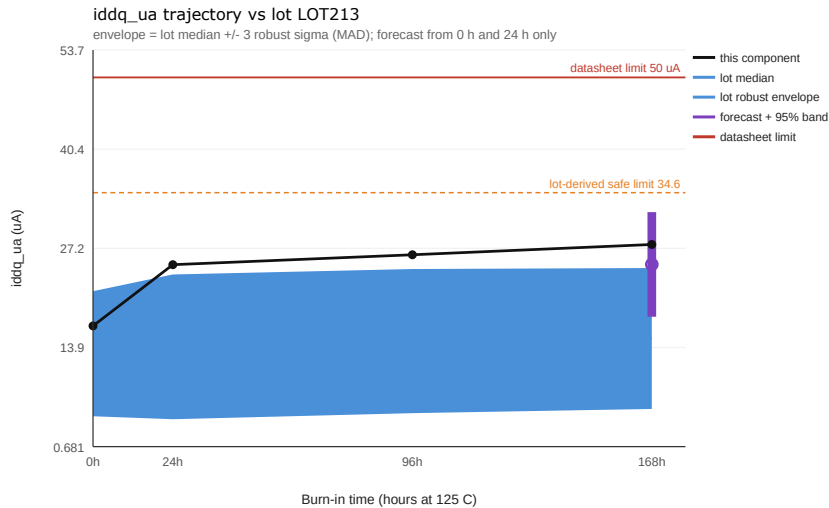
Absolute limit	PASS (54.90 mA vs 65.0 mA max, supply_current_ma)
Lot-relative level	+4.5 robust sigma vs lot median on leakage_na (median 31.69 nA, sigma 7.40 nA, n=496, MAD estimator; AEC-Q001 IQR/1.35 gives 7.43 nA)
Drift 0h to 24h	+8.174 uA (+48.6%) on iddq_ua; lot median drift +0.584 uA (+4.5%), part is +12.3 robust sigma on the lot's drift distribution
Drift rate	0.3406 uA/h (lot median 0.0243 uA/h, 14.0x)
Max interval jump	+16.5 robust sigma on iddq_ua; largest interval change is 6.0x the median of the others (concentrated -> step)
Predicted 168h	25.013 uA (iddq_ua, from 0h and 24h only)
95% upper bound	32.003 uA -> within lot-derived safe limit 34.598 uA
Joint anomaly	Mahalanobis D2 = 41.2 (good-part 99th pct = 15.3); largest contribution leakage_na at 62% of the total
Leakage/delay sign	leakage +4.5 sigma, delay -0.6 sigma -- consistent with the lot's process locus
Spatial check	52 of 64 components on board LOT213-B04 flagged (expected 1.7, p=3.0e-70) -- CLUSTERED, suspect fixture

Data quality	all checkpoints valid
Primary reason	anomaly clusters by board position, not by component
Secondary	discrete step between checkpoints
Action	Do NOT reject the component on this evidence. Raise a fixture/chamber investigation for the affected board and re-test these positions in a different socket.

chamber thermal gradient or socket contact degradation [confidence: well-founded]
Because: 52 flagged components share board LOT213-B04, and the leakage/delay shift has the thermal sign (leaky and slow) rather than the process sign
Caveat: Same sign argument, used the other way. HEAT raises leakage and SLOWS the part; the process corner makes leaky parts FAST. So a fixture artifact and a process outlier push the leakage/delay correlation in OPPOSITE directions and are separable by the sign of the shift, before any spatial evidence is considered. The board clustering is then confirmatory rather than the sole basis.
Suggested next test: map the chamber with a calibrated thermocouple board; re-test the affected positions in a different socket
