Phantom QA results for / fbirn_out/ ses20ch_funcbold_acqcmrrstd_tasktsnr slice 34

bold_acqcmrrstd_tasktsnr_30.xml [percent fluct (trend removed), drift, driftfit] :

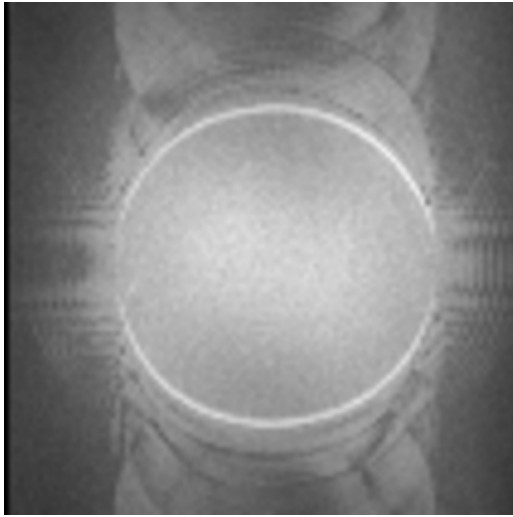
Standard Deviation image

image min: 0, image max: 524.36

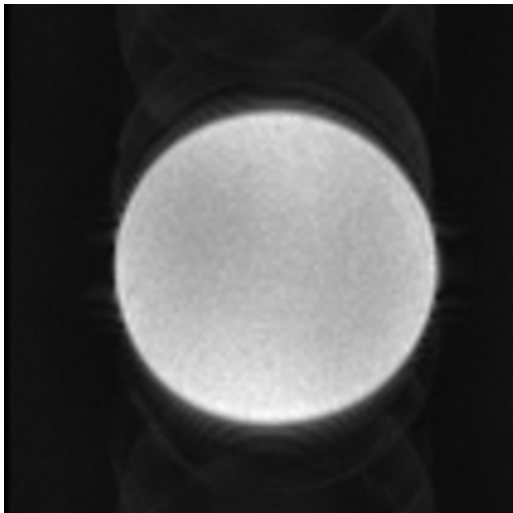
SFNR image

image min: 0, image max: 293.511
