Phantom QA results for / fbirn_out/ ses20ch_funcbold_acqcmrrstd_tasktsnr slice 34

dimensions	106x106x69x200
spacing	2mmx2mmx2mmx2000ms
gap	0mmx0mmx0mmx0ms
scanner	AWP213018
psdname	
examnumber	18e745c6-8069-43
studyid	Stability_20260622
seriesnumber	26
runnumber	1
magneticfield	3

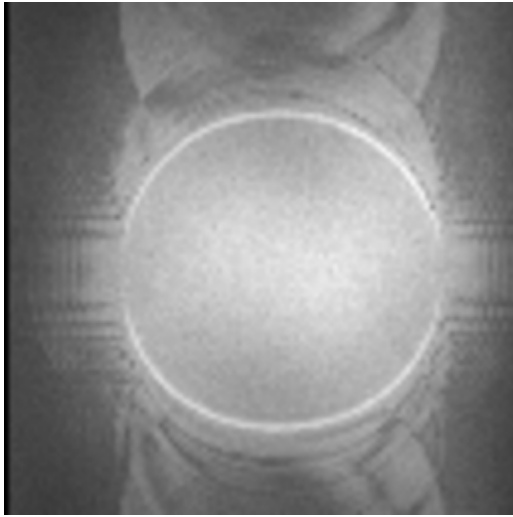
Standard Deviation image

image min: 0, image max: 456.27

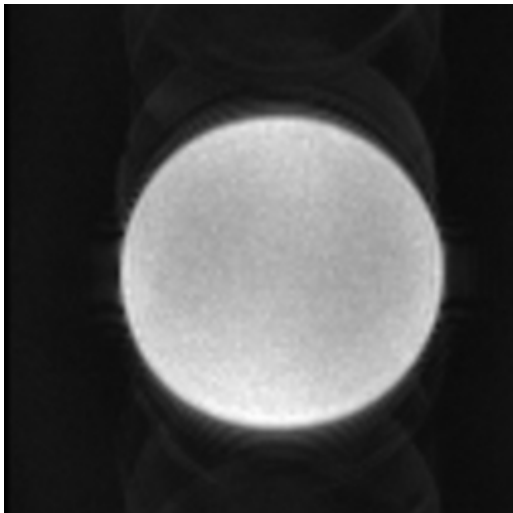
SFNR image

image min: 0, image max: 305.495
