Golf Cart Progress

Sensors, System, Vehicle Interface, Localization

NEWSLab NTU · August 2026

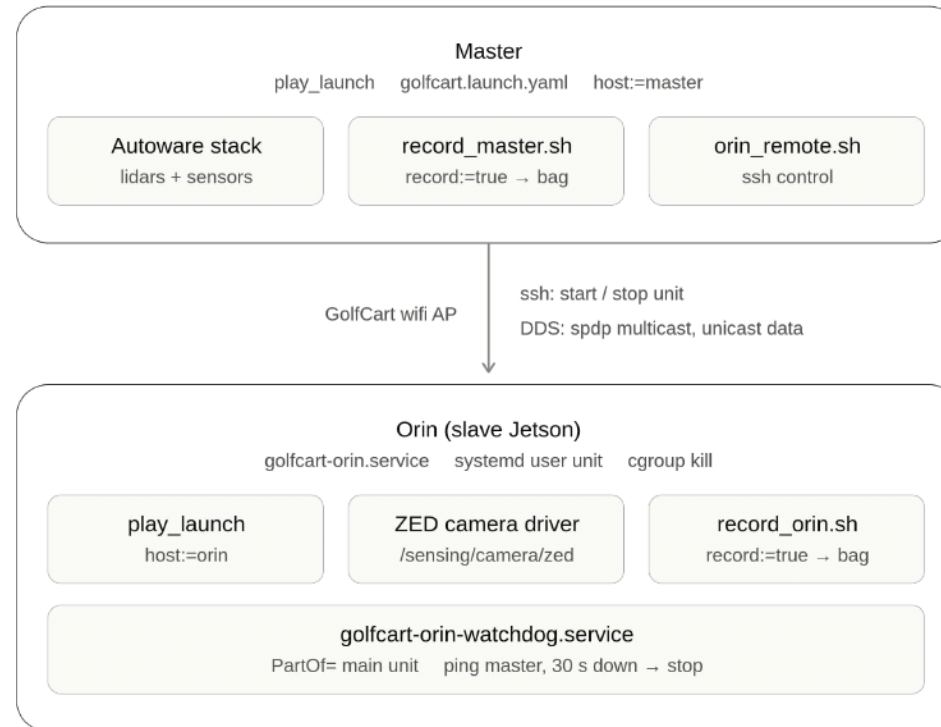
The launch command is wrapped in a systemd user unit, `golfcart-orin.service`. systemd gives singleton startup, clean termination and full logs.

Spawned nodes stay in a control group jail — nothing escapes it, and `systemctl stop` captures them all.

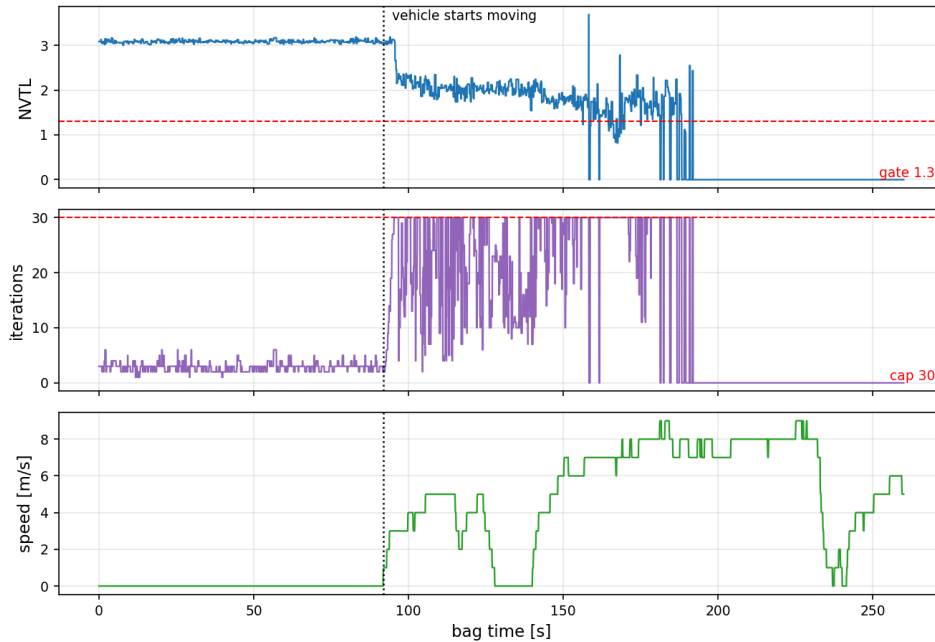
Ranked on **scan-to-map residual** — the distance from each live scan point to the nearest map point — not on NDT's own score.

The ±20 m crop was inherited from AutoSDV and clipped real structure — our returns reach 29 m. Restoring Autoware's ±60 m cut p95 by 72%. The convergence threshold had to move with it: NVTL is a mean per-point score, so it fell while accuracy **improved**.
