Test Report – Performance curve

ISO 9906:2012 Grade 3B2

Pump type	SLV 80.80.92.2.51D.C	Pump Motor	9.2 kW/2 Pole
Product number	98626047

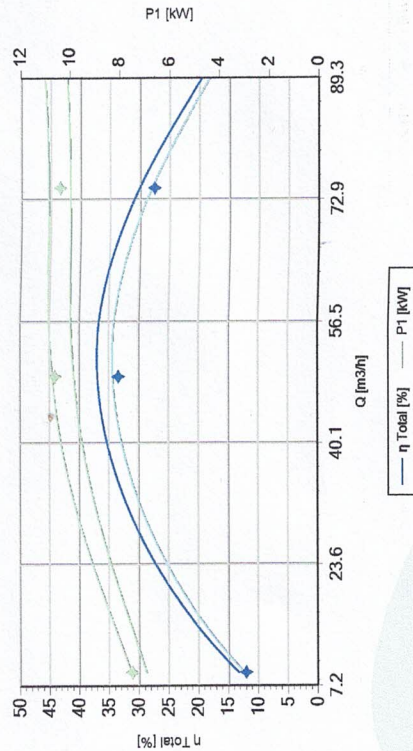
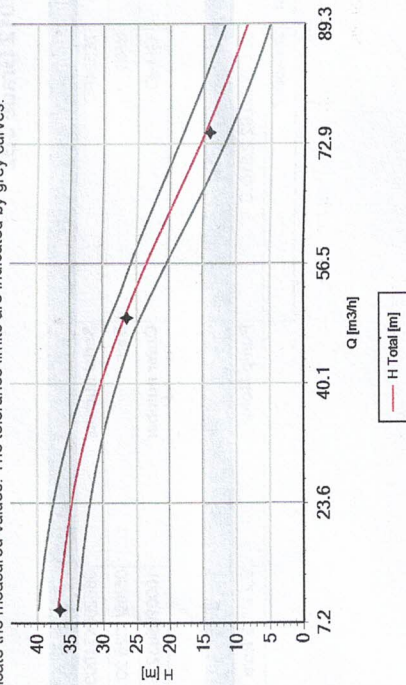
The marks indicate the measured values. The tolerance limits are indicated by grey curves.

This pump is tested according to ISO 9906:2012 grade 3B or ANSI/HI 11.6:2012 grade 3B tolerances. The testbed is constructed and calibrated according to requirements in ISO 9906. Pump is approved according to the tolerances for entire curve, specified in grade 3B.
