MAGNETIC PARTICLE EXAMINATION REPORT

Description: MPI Was Carried Out On Welded Area of MANLIFT JOINTS.

Report No.: 245948

LIFTING EQUIPMENT INSPECTION REPORT	Area Fadli	Inspection Date 04/09/2025		Inspection Time 10:15 AM	Previous Sticker	
					No.BV-24-5211	Issue By BV
Department / Contractor SUDHIR EQUIPMENT RENTAL CO.	Equipment Number S43AG-1354	Equipment Location Site		Inspection Result Pass	New Sticker No. BV-24-7546	
Manufacturer GENIE	Model ZX-135	Capacity 600 LBS/ 272 KG	Type MEWP	Equipment Serial Number ZX13513-2164	Sticker Expiration Date 03/03/2026

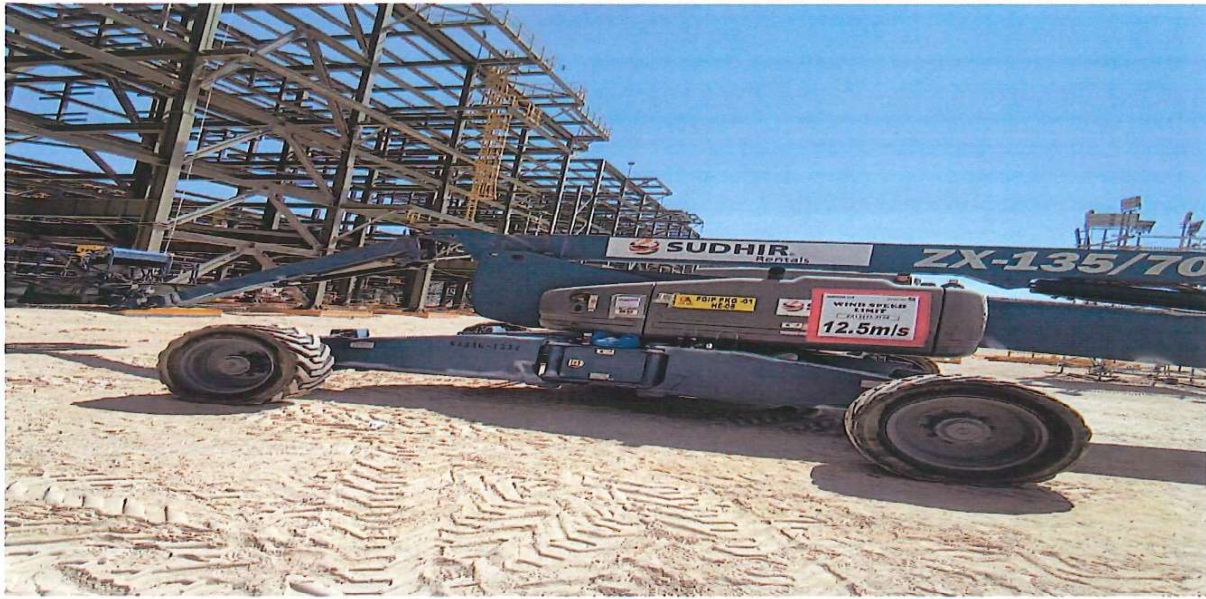
IMAGE-1 OF JOB ↓

The above mentioned Welded Joints of the Manlift were tested using the Magnetic Partical Test (MPT) Method. No relevant indication were observed, and the joints are acceptable as per the applicable code. Refer Page 2 for image of testing.
