NASA TN D-6977

APOLLO EXPERIENCE REPORT — LUNAR MODULE ELECTRICAL POWER SUBSYSTEM

by Arturo B. Campos

Manned Spacecraft Center

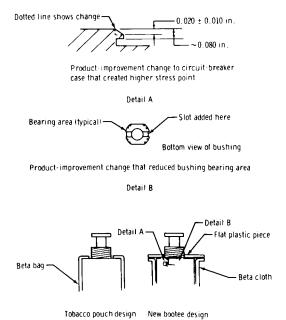
Figure 3. - Circuit-breaker-case improvements.

After the fire in Apollo CM 012, the prime contractor covered the circuit breakers with Beta-cloth bootees to stop the propagation of a fire. Subsequently, cracks were found in the case around the base of the threaded mounting bushing of some hot-wire-type breakers. Two factors contributed to this condition. Firstly, the circuit-breaker load-bearing mounting surface was subjected to uneven stresses because of crumpled Beta cloth between the mounting surface and the panel. Secondly, the load-bearing area of the breaker threaded bushing had been reduced by a product-improvement change.

When the prime contractor instituted trip-characteristic testing in the fall of 1968, it was found that some bimetallic circuit breakers did not trip. Both Apollo spacecraft prime contractors assisted the breaker manufacturer in performing electrical trip testing on approximately 100 circuit breakers. Based on the test results, it was stipulated that the electrical trip life should be limited to 20 trip cycles, an NASA-approved specification change. Failure analysis of circuit breakers indicated that, with increasing triptime, the bimetallic plate seemed to bind with the latching bracket as shown in figure 4.

Figure 4. - Lunar module bimetallic circuit breakers.

The prime contractor modification to resolve this problem was twofold. The Beta-cloth-bootee design was changed from the so-called tobacco pouch design, in which a string was drawn to close the pouch around the mounting bushing, to one that

incorporated a piece of flat plastic between the circuit-breaker mounting surface and the panel (fig. 3). In addition, the torque on the threaded-bushing mounting nut was reduced from 30 to 20 inch-pounds. The effectiveness of a good mount at the lower torque values was proven by means of testing.

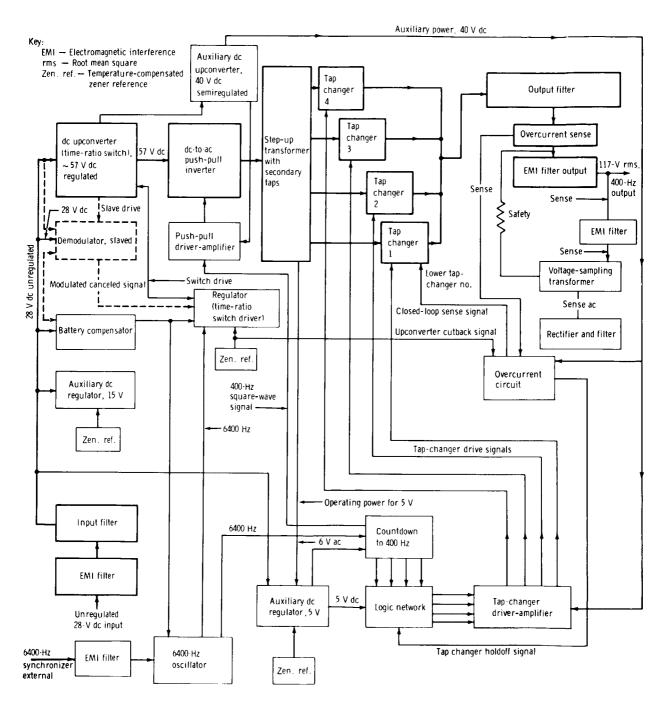
Figure 5. - Lunar module general-purpose inverter block diagram.

After qualification, an inverter in the LM-3 vehicle failed preflight. The output of the inverter was intermittent. The problem was attributed to separation of the oscillator-capacitor lead solder. When the joint on the qualification unit was inspected, the same solder separation as that observed on the failed LM-3 joint was noted. When the joints were further examined, it was determined that the condition was attributable to the nonwetting characteristics of the metals used in the lead fabrication; that is, dumet lead material on the capacitor, copper flashing of this lead, and tin-dipping of the lead in 50/50 solder. This 50/50 solder made the lead noncompatible as explained in the following paragraph.

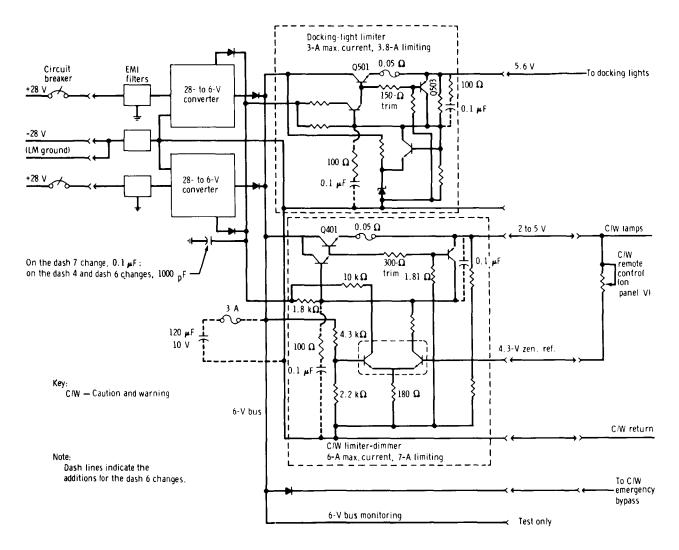
Figure 6. - Lighting-control dc section.

During the ground testing of LM-3 at the prime contractor's plant, an electromagnetic interference problem was found to cause noise in the communication headset and a shift in the flight director attitude indicator. In the process of troubleshooting, two LCA units were damaged when inadvertent grounding of the LCA circuit through a grounded oscilloscope caused failure of a zener diode and the remote-control potentiometer. Two problems were revealed. Firstly, a steady-state noise level of 0.2 to 0.4 volt, 4 to 10 megahertz, was seen on the 2- to 5-volt circuit. Secondly, a transient peak voltage of 20 to 25 volts at 250 kilohertz during initial turnon was seen on the 15-volt output of the dc-to-dc converters. The energy contents of the transient and the noise were considered negligible insofar as causing permanent damage to the LCA.

Circuit analysis and testing by the vendor indicated that the noise originated in the 15-volt section that provided power to the dimmer and current-limiting circuits and that decoupling was needed between the switching elements in the dimmer-limiter modules. The decoupling capacitors and filter capacitors installed in the various modules to solve the problem are shown in figure 6.
