SOCIETY FOR ECOSYSTEM RESTORATION
IN NORTHERN BRITISH COLUMBIA

Restoring Fish Passage in the Peace Region - 2024

PEA-F24-F-3944-DCA

DRAFT Version 0.0.2 2025-03-26

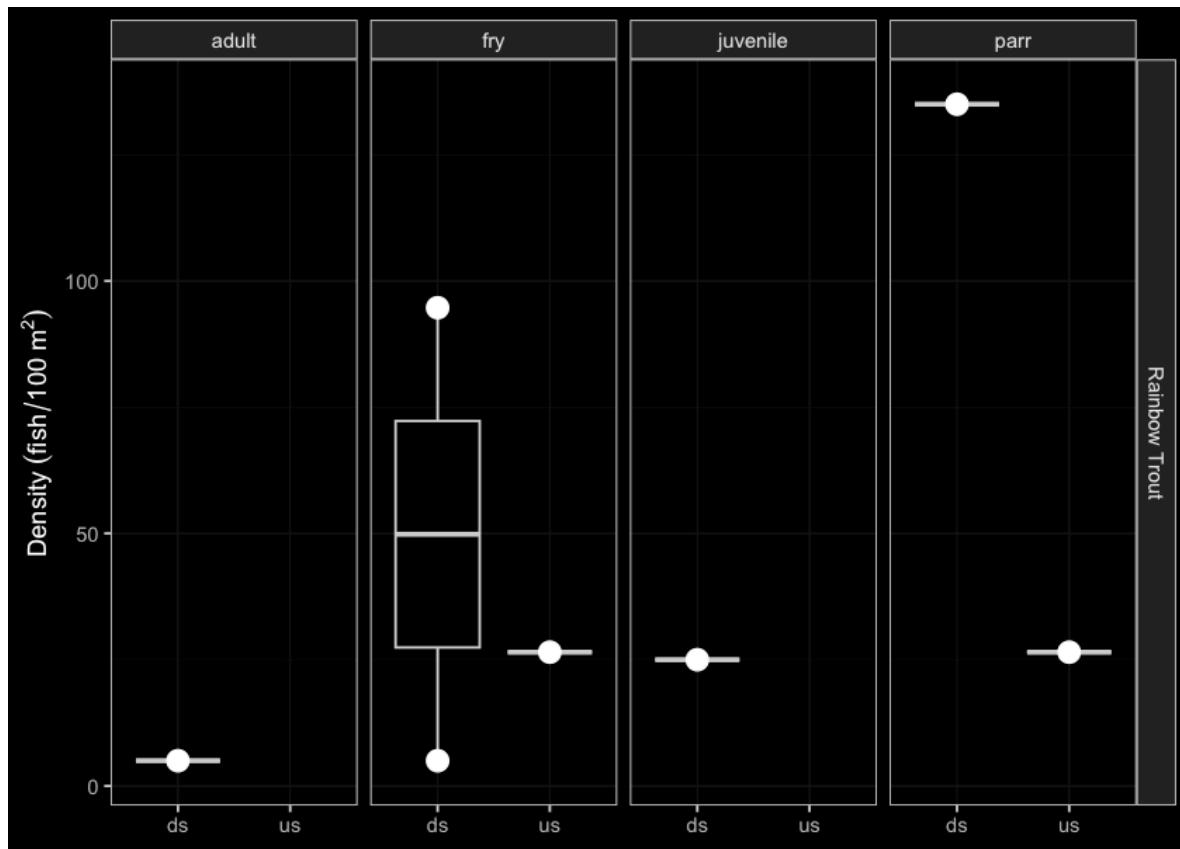
Figure 4.9: Densities of fish (fish/100m²) captured upstream and downstream of PSCIS crossing 198692.

Approximately 2.3km of bull trout rearing habitat is modelled upstream, and the habitat was rated as medium value for anadromous spawning and rearing. The 0.34m outlet drop at PSCIS crossing 198692 likely inhibits juvenile anadromous fish passage and the crossing is rated as a high priority for replacement.

If there are no plans for further logging in the area, removing the crossing and deactivating the road should be considered as a fish passage remediation option. If logging activities are planned to continue and restoration/maintenance activities proceed, replacement of the Kerry Lake FSR

crossing with a bridge (15 m span) is recommended. At the time of reporting in 2025, the cost of the work is estimated at \$ 450,000.
