# SOCIETY FOR ECOSYSTEM RESTORATION IN NORTHERN BRITISH COLUMBIA

# Restoring Fish Passage in the Peace Region - 2024

PEA-F24-F-3944-DCA

DRAFT Version 0.1.0 2025-03-31

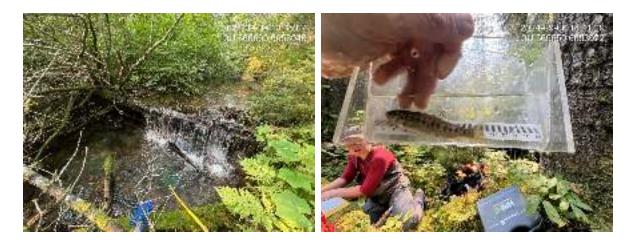
Figure 5.4: Left: Typical habitat electrofished upstream of PSCIS crossing 125180. Right: Rainbow trout captured upstream of PSCIS crossing 125180.
