SOCIETY FOR ECOSYSTEM RESTORATION
IN NORTHERN BRITISH COLUMBIA

Restoring Fish Passage in the Peace Region - 2024

PEA-F24-F-3944-DCA

Prepared for
Fish and Wildlife Compensation Program
and
Fish Passage Technical Working Group

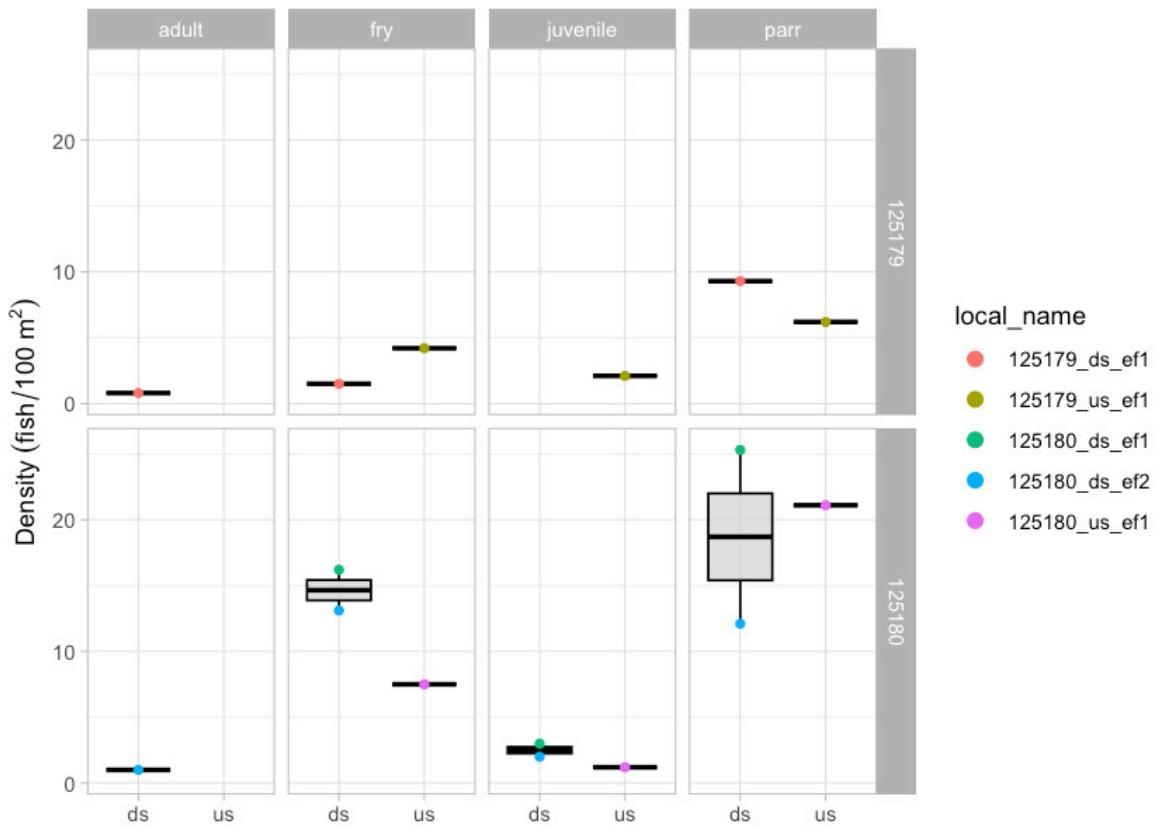
Figure 5.1: Densities of rainbow trout (fish/100m²) captured upstream and downstream of PSCIS crossings 125179 and 125180. Note that two sampling events were conducted within the same sampling site on different days - downstream of site 125180

As per recommendations in Irvine (2020) and Irvine and Winterscheidt (2023) - to provide reference site data for comparison, electrofishing was conducted not only at the site of the remediation (PSCIS 125179) - but also at PSCIS crossing 125180, a similarly sized culverted stream - located approximately 660m east of the subject crossing (Irvine and Winterscheidt 2023; Irvine 2020). Another site (PSCIS crossing 125186) was also scoped as a potential reference site - however the stream was almost completely dry in 2024 (with the exception of the outlet pool and intermittent shallow pool sections).

through coordination from SERNbc. Effectiveness monitoring at the site was conducted in 2024 with the structure in stable condition with no maintenance required at the time of reporting. Lessons learned from the work - to be leveraged towards future projects - include reducing the amount of riprap material placed within the bankfull channel width and replanting of areas where riparian vegetation is removed during construction. This crossing serves as an example of a successful replacement, and the lessons learned through its implementation can help build stakeholder confidence in advancing additional fish passage remediation projects.

Resampling of fish at the restoration and reference sites in future years is recommended to build our understanding of fish use, movement and health in the subject streams. Acquisition of additional aerial imagery in the future is also recommended so that imagery and elevation models can be compared with data collected immediately following replacement (2022) to evaluate stream morphology changes and riparian recovery since construction.

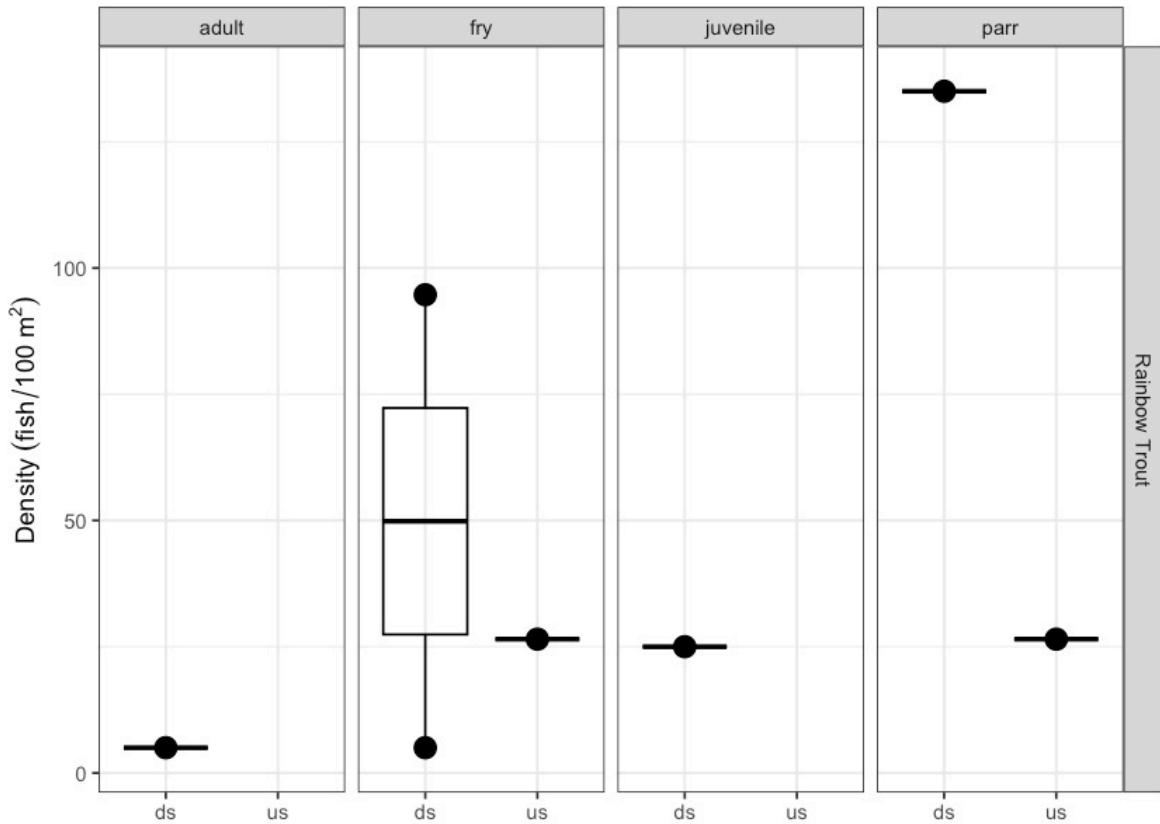
Figure 5.8: Densities of fish (fish/100m²) captured upstream and downstream of PSCIS crossing 198692.

The stream was surveyed upstream from crossing 198692 for 500m . The stream was noted as having significant flow for the time of year. The habitat was rated as medium value, with patches of gravel suitable for spawning resident rainbow trout and bull trout present (Figure [5.9](#)). The stream narrowed into a canyon approximately 150m upstream of Kerry FSR (Figure [5.10](#)). The dominant substrate was cobbles with gravels sub-dominant. The average channel width was 4m, the average wetted width was 1.5m, and the average gradient was 5%. Total cover amount was rated as abundant with undercut banks dominant. Cover was also present as small woody debris, large woody debris, deep pools, and overhanging vegetation.

Approximately 2.3km of bull trout rearing habitat is modelled upstream, and the habitat was rated as medium value for anadromous spawning and rearing. The 0.34m outlet drop at PSCIS crossing 198692 likely inhibits juvenile anadromous fish passage and the crossing is rated as a high priority for replacement. Although bull trout were not captured at the time of assessment, their absence does not confirm exclusion from the stream. The stream was noted as having significant flow for the time of year, however, flow levels should be further investigated when evaluating the streams importance for bull trout spawning.

If there are no plans for further logging in the area, removing the crossing and deactivating the road should be considered as a fish passage remediation option. If logging activities are planned to continue and restoration/maintenance activities proceed, replacement of the Kerry Lake FSR crossing with a bridge (15 m span) is recommended. At the time of reporting in 2025, the cost of the work is estimated at \$ 450,000.

Located on a low-traffic forest service road, remediation of this crossing would not require significant involvement. The road falls under the tenure of the Ministry of Forests, and if there are no plans for further logging in the area, removing the crossing and deactivating the road could be considered as a fish passage remediation option. If logging activities are planned to continue, opportunities could be explored to collaborate with road tenure holders to replace the crossing.
