## Restoring Fish Passage in the Peace Region - 2024

PEA-F24-F-3944-DCA

Prepared for  
Fish and Wildlife Compensation Program  
and  
Fish Passage Technical Working Group

Prepared by  
Al Irvine, B.Sc., R.P.Bio. and Lucy Schick, B.Sc.  
New Graph Environment Ltd.  
on behalf of  
Society for Ecosystem Restoration in Northern BC

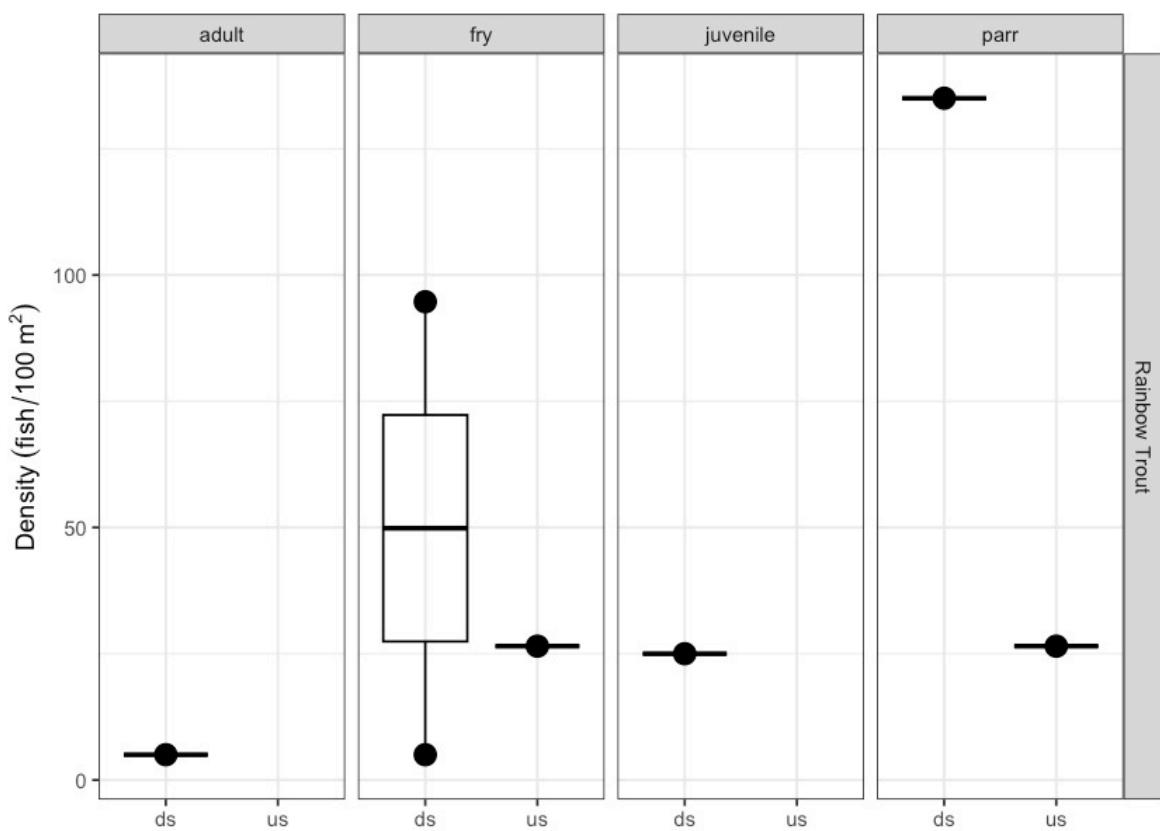
Approximately 2.3km of bull trout rearing habitat is modelled upstream, and the habitat was rated as medium value for anadromous spawning and rearing. The 0.34m outlet drop at PSCIS crossing 198692 likely inhibits juvenile anadromous fish passage and the crossing is rated as a high priority for replacement. Although bull trout were not captured at the time of assessment, their absence does not confirm exclusion from the stream. The stream was noted as having significant flow for the time of year, however, flow levels should be further investigated when evaluating the streams importance for bull trout spawning.

Figure 5.6: Densities of fish (fish/100m<sup>2</sup>) captured upstream and downstream of PSCIS crossing 198692.

If there are no plans for further logging in the area, removing the crossing and deactivating the road should be considered as a fish passage remediation option. If logging activities are planned to continue and restoration/maintenance activities proceed, replacement of the Kerry Lake FSR

crossing with a bridge (15 m span) is recommended. At the time of reporting in 2025, the cost of the work is estimated at \$ 450,000.
