Restoring Fish Passage in the Peace Region - 2024

PEA-F24-F-3944-DCA

Prepared for
Fish and Wildlife Compensation Program
and
Fish Passage Technical Working Group

Version 0.1.2 2025-05-16

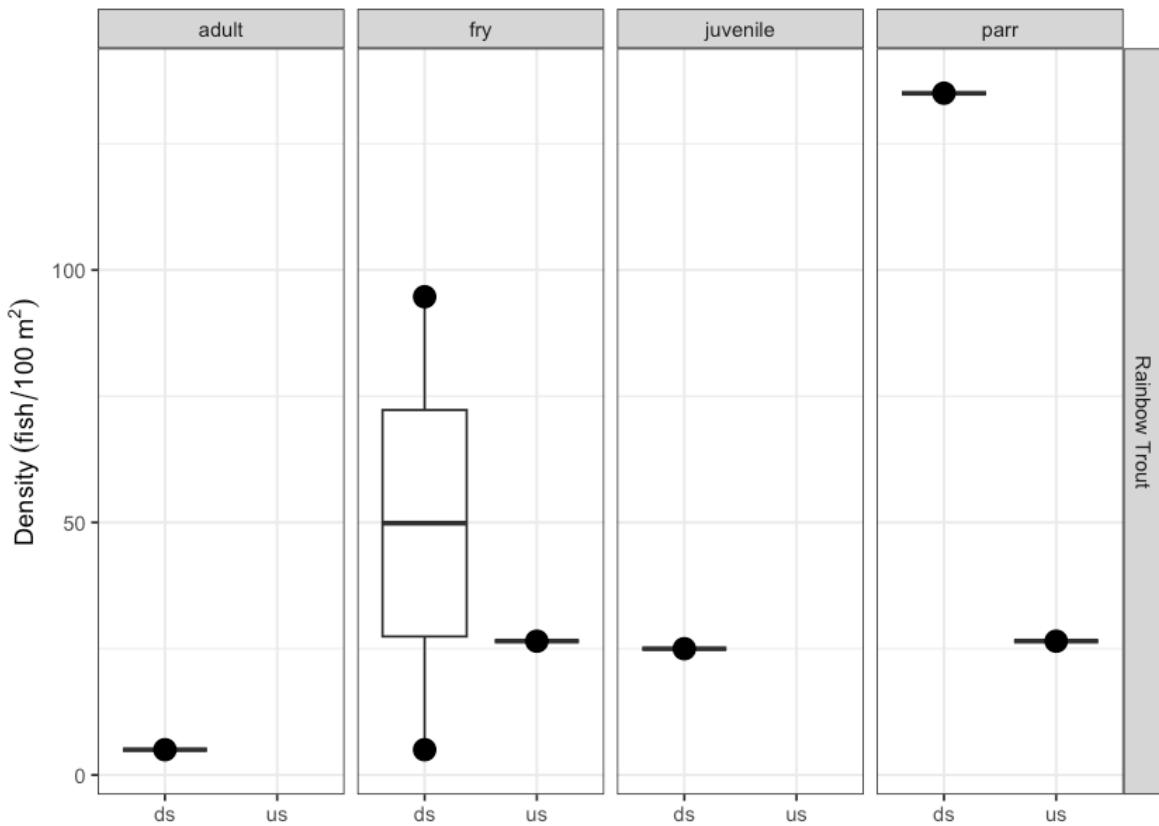
Figure 5.8: Densities of fish (fish/100m²) captured upstream and downstream of PSCIS crossing 198692.

The stream was surveyed upstream from crossing 198692 for 500m . The stream was noted as having significant flow for the time of year. The habitat was rated as medium value, with patches of gravel suitable for spawning resident rainbow trout and bull trout present (Figure [5.9](#)). The stream narrowed into a canyon approximately 150m upstream of Kerry FSR (Figure [5.10](#)). The average channel width was 4m, the average wetted width was 1.5m, and the average gradient was 5%.The dominant substrate was cobbles with gravels sub-dominant.Total cover amount was rated as abundant with undercut banks dominant. Cover was also present as small woody debris, large woody debris, deep pools, and overhanging vegetation.

Approximately 2.3km of bull trout rearing habitat is modelled upstream, and the habitat was rated as medium value for anadromous spawning and rearing. The 0.34m outlet drop at PSCIS crossing 198692 likely inhibits juvenile anadromous fish passage and the crossing is rated as a high priority for replacement. Although bull trout were not captured at the time of assessment, their absence does not confirm exclusion from the stream. The stream was noted as having significant flow for the time of year, however, flow levels should be further investigated when evaluating the streams importance for bull trout spawning.

If there are no plans for further logging in the area, removing the crossing and deactivating the road should be considered as a fish passage remediation option. If logging activities are planned to continue and restoration/maintenance activities proceed, replacement of the Kerry Lake FSR crossing with a bridge (15 m span) is recommended. At the time of reporting in 2025, the cost of the work is estimated at \$ 450,000.

Located on a low-traffic forest service road, remediation of this crossing would not require significant involvement. The road falls under the tenure of the Ministry of Forests, and if there are no plans for further logging in the area, removing the crossing and deactivating the road could be considered as a fish passage remediation option. If logging activities are planned to continue, opportunities could be explored to collaborate with road tenure holders to replace the crossing.
