## Restoring Fish Passage in the Peace Region - 2024

PEA-F24-F-3944-DCA

Prepared for  
Fish and Wildlife Compensation Program  
and  
Fish Passage Technical Working Group

DRAFT Version 0.0.2 2025-03-27

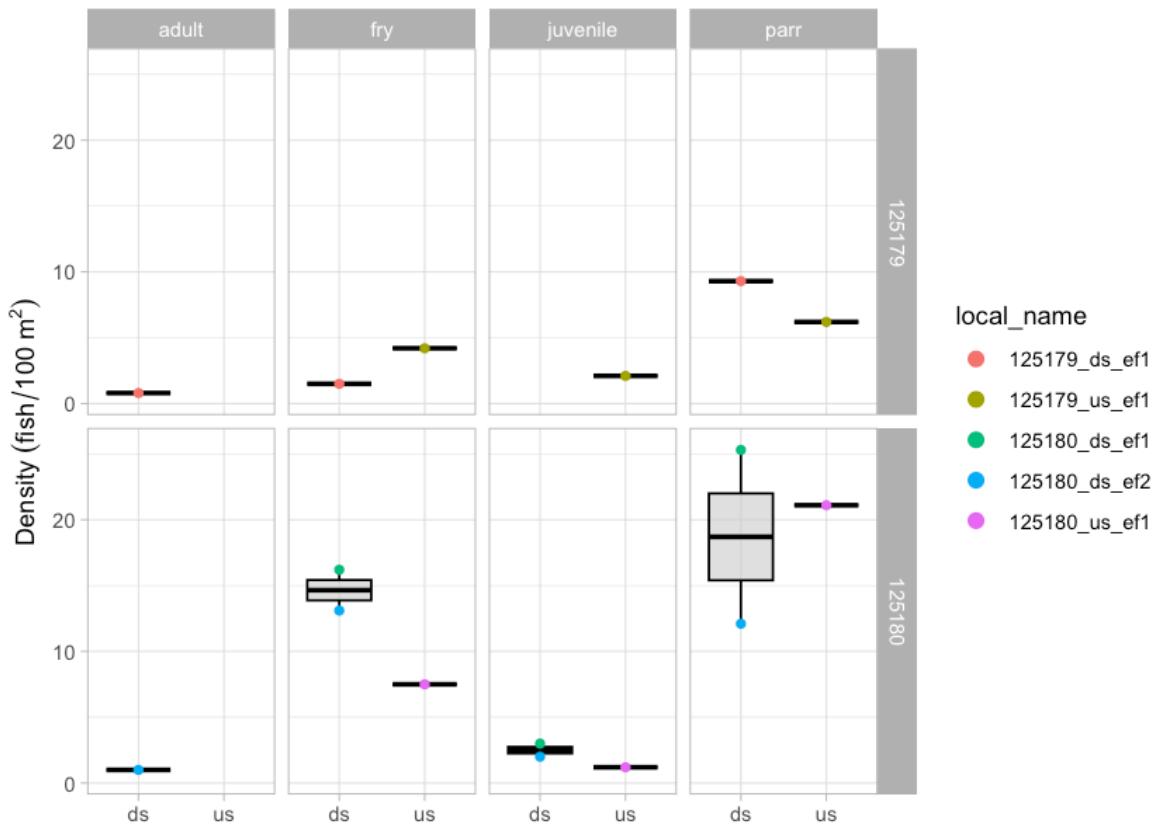
Figure 4.4: Densities of rainbow trout (fish/100m<sup>2</sup>) captured upstream and downstream of PSCIS crossings 125179 and 125180. Note that two sampling events were conducted within the same sampling site on different days - downstream of site 125180

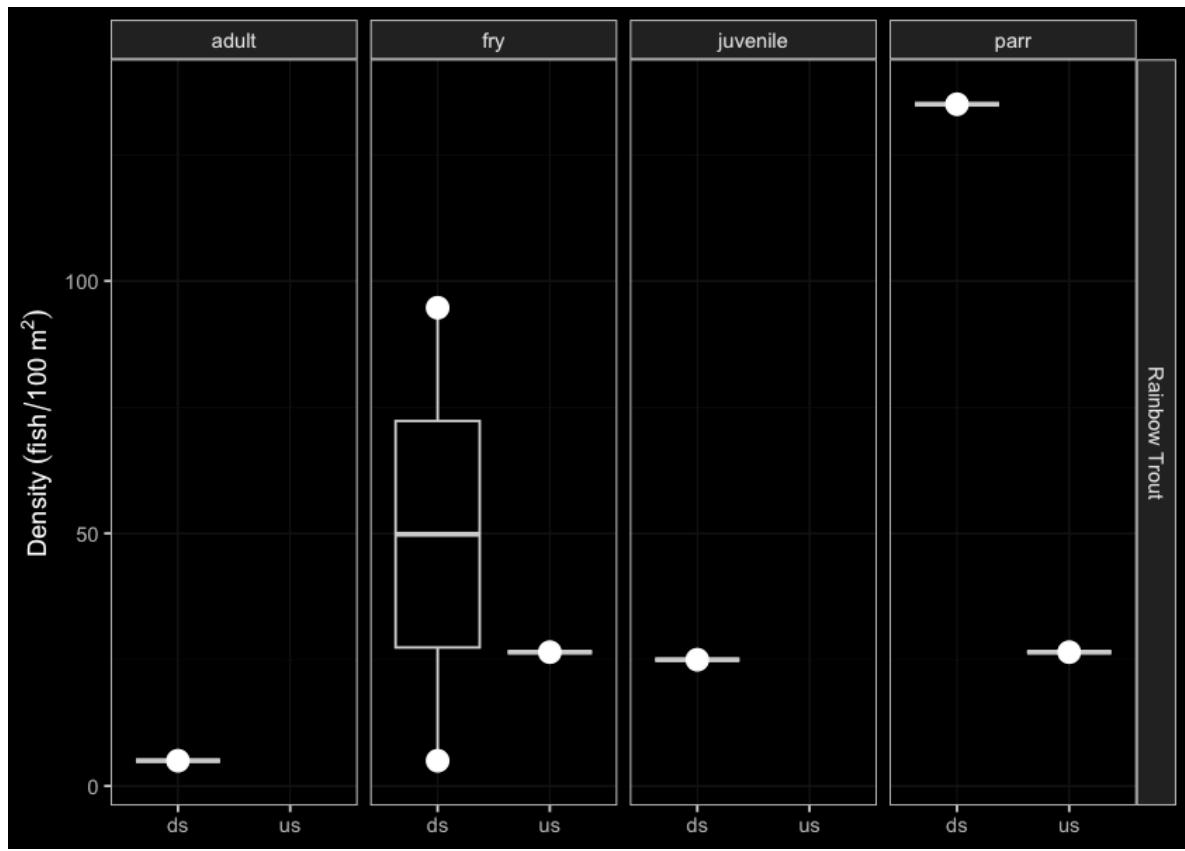
Approximately 2.3km of bull trout rearing habitat is modelled upstream, and the habitat was rated as medium value for anadromous spawning and rearing. The 0.34m outlet drop at PSCIS crossing 198692 likely inhibits juvenile anadromous fish passage and the crossing is rated as a high priority for replacement.

Figure 4.9: Densities of fish (fish/100m<sup>2</sup>) captured upstream and downstream of PSCIS crossing 198692.

If there are no plans for further logging in the area, removing the crossing and deactivating the road should be considered as a fish passage remediation option. If logging activities are planned to continue and restoration/maintenance activities proceed, replacement of the Kerry Lake FSR

crossing with a bridge (15 m span) is recommended. At the time of reporting in 2025, the cost of the work is estimated at \$ 450,000.

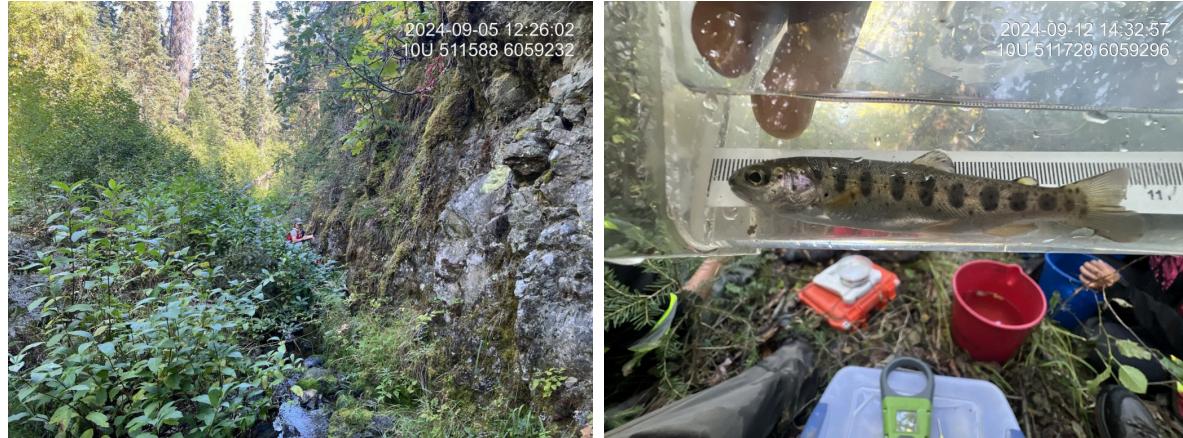
Figure 4.11: Left: Canyon located approximately 150m upstream of PSCIS crossing 198692. Right: Rainbow trout captured upstream of PSCIS crossing 198692.
