2025 PVN FME Q1 Work Report

Dept.: BG6-Manufacturing&Operation Management Center.-Vietnam Manufacturing Div.-PVN1 Factory-FME Dept.-Automation Sec.
Name: Arthur Nguyen 阮春松
Date: 2025/03/19

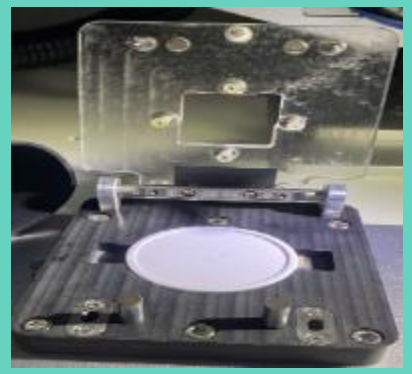
4. Jig of UI UDR7 laser engraving machine causes the product to be misaligned after laser engraving, so it has been improved.

The material fixing pin is not tight, plus there is still a gap on both sides of the jig, so when the jig is closed, it may still be misaligned during laser engraving, causing the laser engraving NG rate up to 50%.

Because the Jig still has a certain gap and the plug is not tight, when OP puts material into the JIG and closes it, it can still be offset to both sides, causing the laser engraving to be NG. Causing the laser engraving NG rate up to 50%.

After changing the Jig, the improvement can be seen immediately. The laser engraving deviation rate is significantly reduced, along with the simple operation of the new Jig, it helps OP get used to it easier and faster, improving productivity.
