Colibri Scan Report

Licence Plate
0742 GCK

Date
29.10.2026 9:48

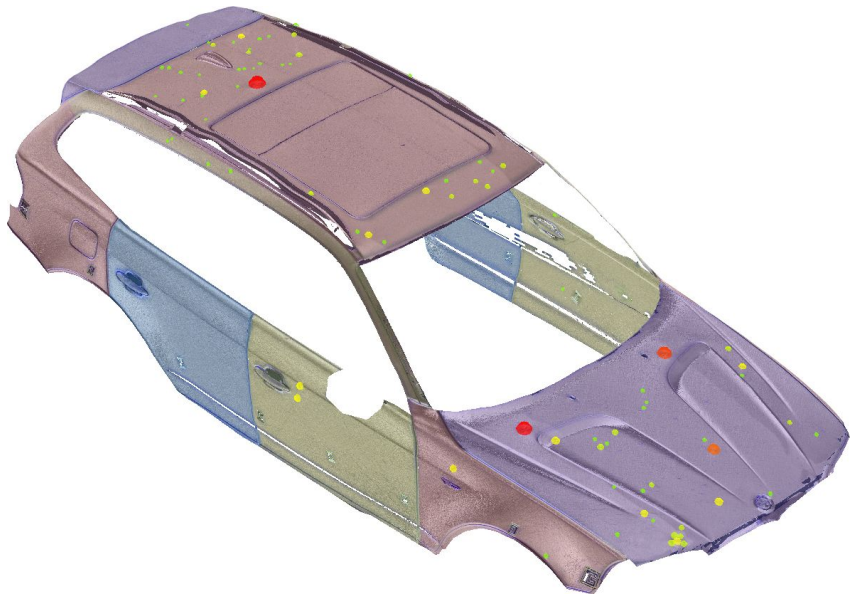
Total Dents
All: 84 Ø: 30mm

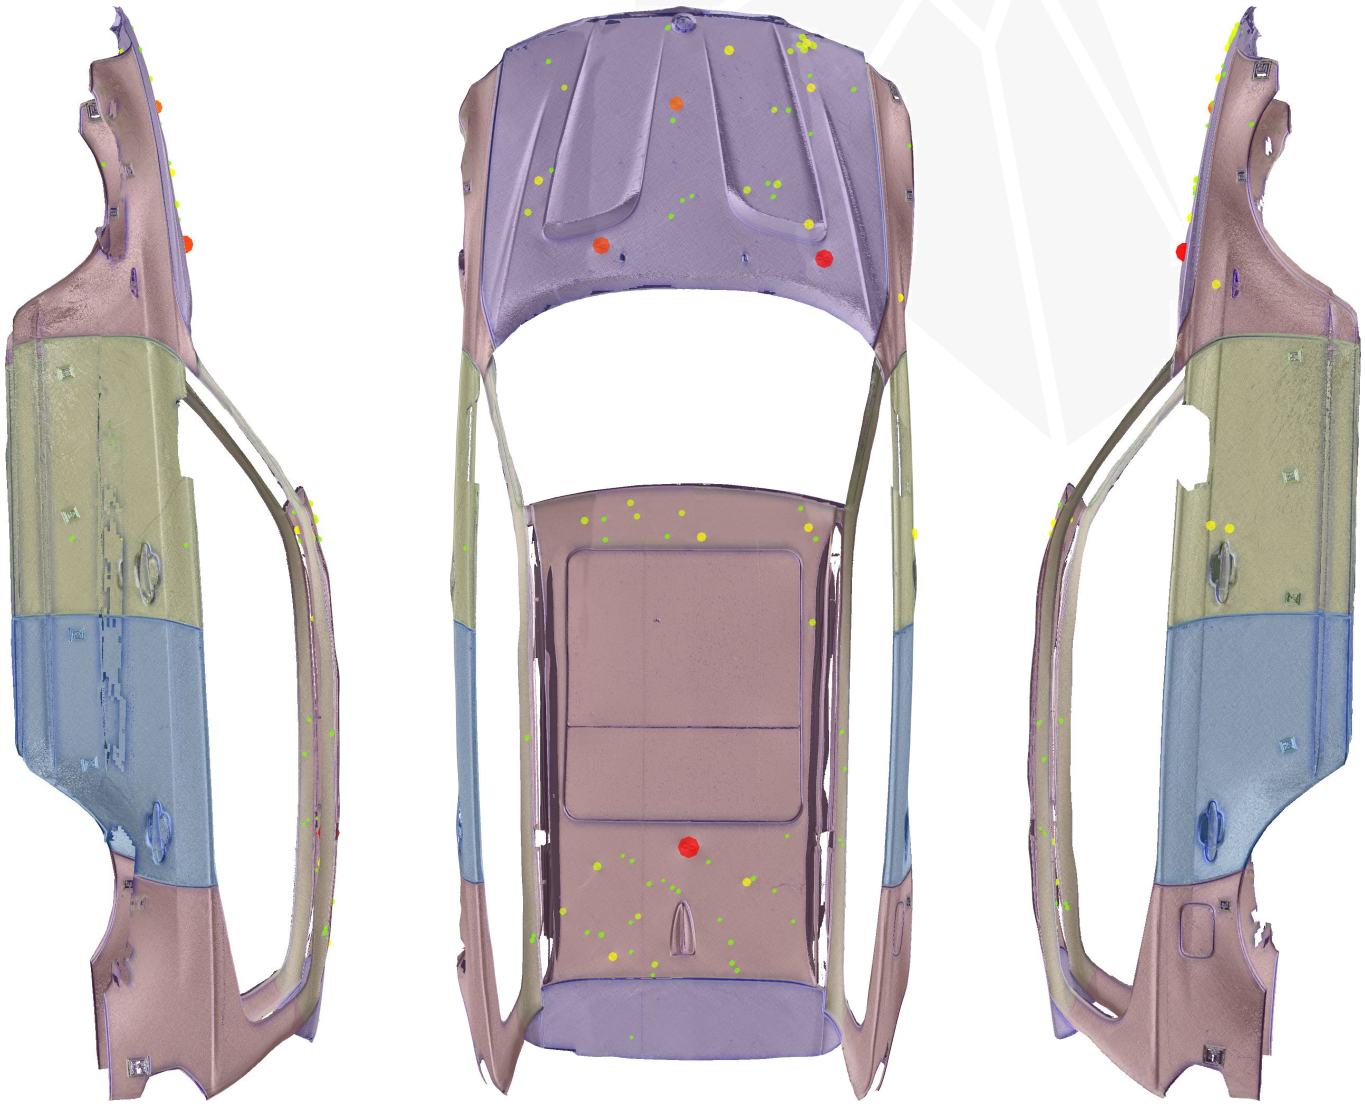
10mm	20mm	30mm	40mm	50mm	60mm	70mm	80mm	Total	Φ
Fender Front Left										
Door Front Left		2							2	20
Door Rear Left										
Fender Rear Left										
Roof Spar Left		3							3	20

10mm	20mm	30mm	40mm	50mm	60mm	70mm	80mm	Total	Φ
Bonnet		13	10	5		1	1	1	31	31
Roof		25	9	4				1	39	26
Trunk Top		1							1	20
Trunk Bottom	-	-	-	-	-	-	-	-	-	-

10mm	20mm	30mm	40mm	50mm	60mm	70mm	80mm	Total	Φ
Fender Front Right		1		1					2	30
Door Front Right				2					2	40
Door Rear Right										
Fender Rear Right										
Roof Spar Right		4							4	20
