Senior Home Safety

HOME SAFETY ASSESSMENT REPORT · SAMPLE REPORT

PREPARED FOR
Margaret Smith

PROPERTY
123 Sample Street SW, Calgary, AB

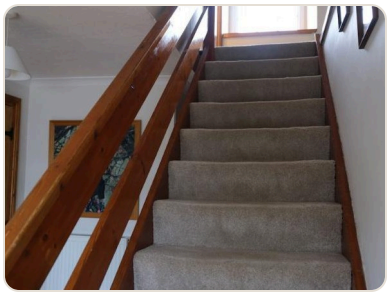
OBSERVED Rails stop level with the first and last riser.

STANDARD B652 §5.6.3 — Extends min 300mm past top and bottom.

From our recent market research, the price of this work in Calgary should be approximately **$210**, before GST.
