COMMERCIAL HVAC / CONDITION REPORT

Arrigo CDJR Sawgrass

Required replacements & water damage

Inspection: September 29, 2026 | Updated: October 9, 2026

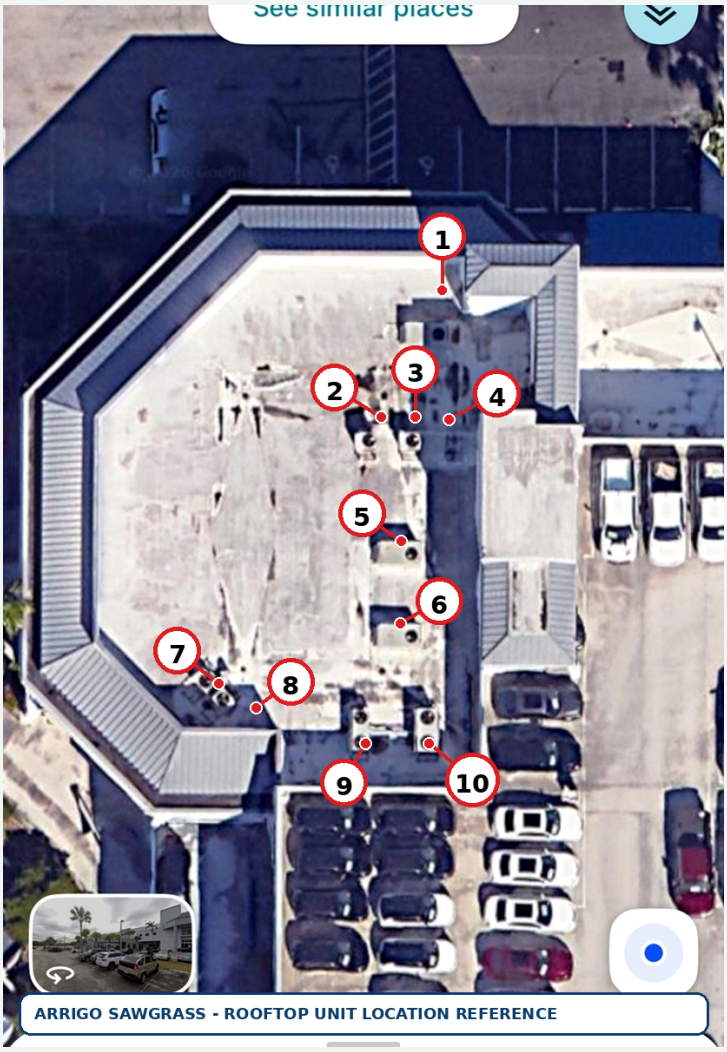
Rooftop unit locations & status

UNIT 01
Immediate service - flooding

UNIT 02
Repaired - monitor

UNIT 03
Replacement required

UNIT 04
Maintenance / repair review

UNIT 07
Replace - Finance

UNIT 08
Recommend with Unit 7

UNIT 09
Replace - Executive area

UNIT 10
Replace - Service Advisor

Numbered markers identify unit locations from the supplied rooftop reference. Marker outlines are location identifiers; the adjacent status list shows the current service and replacement priorities.

Critical / replacement: Units 1, 3, 7, 9 and 10.
Service / monitor / planned replacement: Units 2, 4 and 8.
Operational / maintain: Units 5 and 6.

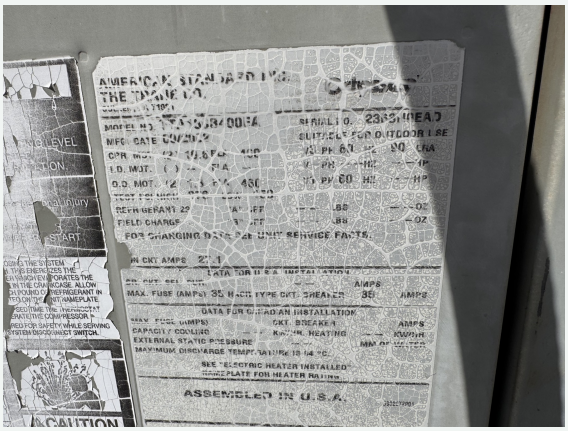
Unit 9 | IMG_4048

Unit 9 | Second Floor - Executive & Executive Assistant

REPLACEMENT REQUIRED

Location label: unit 9 second floor executive and excutive assistant

Approve replacement scopes. Verify capacity, electrical service, supports, piping and access before selecting equipment.
