Ultrasonic Examination Report

Client:	SAChem	**Location:**	**2311 Pipeline Rd. Cleburne, Tx 76033**	**Report No.**	1 OF 1
Procedure:	TNDT-UT-003 Rev. 3			**Date:**	11/4/2025
Code/Specification:	ASME Sec. V			**P/O No.**	OilPro003
Item Description:	Vessel			**Total NDT SC #**	200-25-487
Scope of Examination:	UT Thickness on Specified Areas			**Dwg:**	54-11-002 Methylchloride Storage

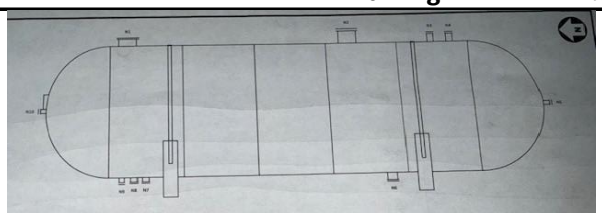
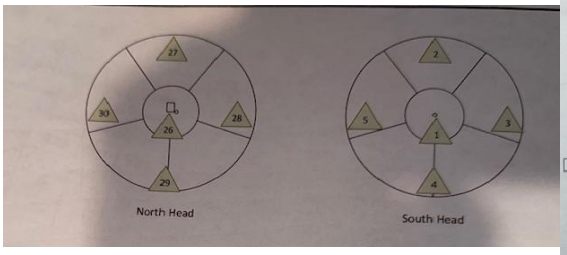
Drawing

Performed Ultrasonic Thickness Test on preset areas
Readings on vessel were taken clockwise faceing North
Readings on Nozzels were taken on top of pipe
going clockwise, or on North side working clockwise.
0° on 24 Could not be accessed due to catwalk.
N1 Readings were unavalible due to not getting a redaing.
N5 is a Threaded Pipe
N10 is a Blank Flange
