Ultrasonic Examination Report

Client:	SAChem	**Location:**	**2311 Pipeline Rd. Cleburne, Tx 76033**	**Report No.**	1 OF 1
Procedure:	TNDT-UT-003 Rev. 3			**Date:**	11/4/2025
Code/Specification:	ASME Sec. V			**P/O No.**	OilPro003
Item Description:	Vessel			**Total NDT SC #**	200-25-487
Scope of Examination:	UT Thickness on Specified Areas			**Dwg:**	54-11-001 Trimethylamine Storage

Client:	SAChem	**Location:**	**2311 Pipeline Rd. Cleburne, Tx 76033**	**Report No.**	1 OF 1
Procedure:	TNDT-UT-003 Rev. 3			**Date:**	10/23/2025
Code/Specification:	ASME Sec. V			**P/O No.**	OilProo003
Item Description:	Triethylamine Vessel			**Total NDT SC #**	200-25-467
Scope of Examination:	UT Thickness on Specified Areas			**Dwg:**	57-11-001

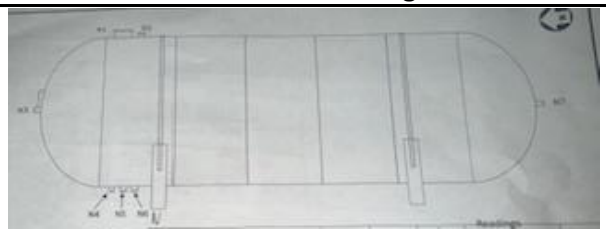
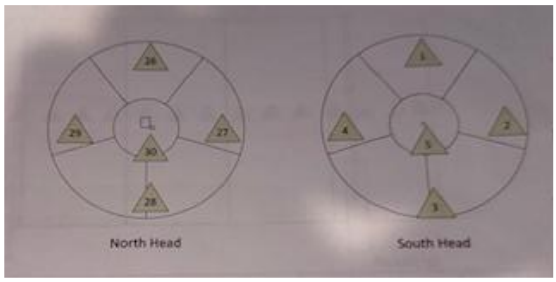
Drawing

Performed Ultrasonic Thickness Test on preset areas
Readings on vessel were taken clockwise faceing North
Readings on Nozzels were taken on top of pipe
going clockwise, or on North side working clockwise.
N1 has no readings due to not have a neck on Manway
N3 is a Blank Flange
N5 is a Threaded Pipe
24 & 25 is N/A due to catwalk obstruction

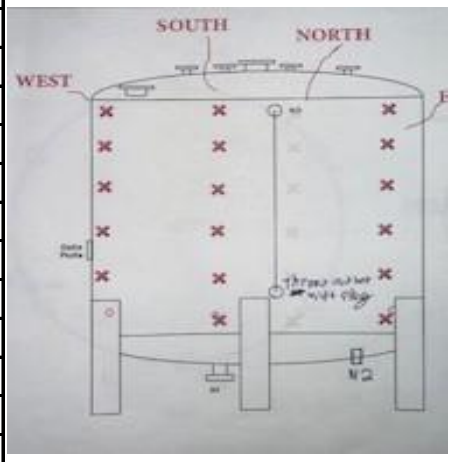
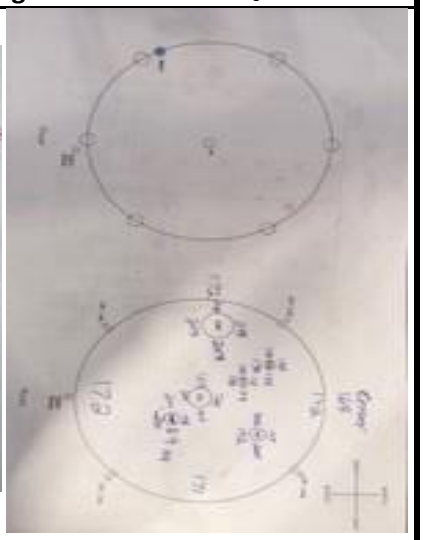
Drawing

Performed Ultrasonic Thickness Test on preset areas
Readings on vessel were taken clockwise faceing North
Readings on Nozzels were taken on top of pipe
going clockwise, or on North side working clockwise.
See attached Thickness Reading
