Fair Wear: deposit evidence pack

Demo flat (simulated) · 2-year tenancy · generated 30 October 2026

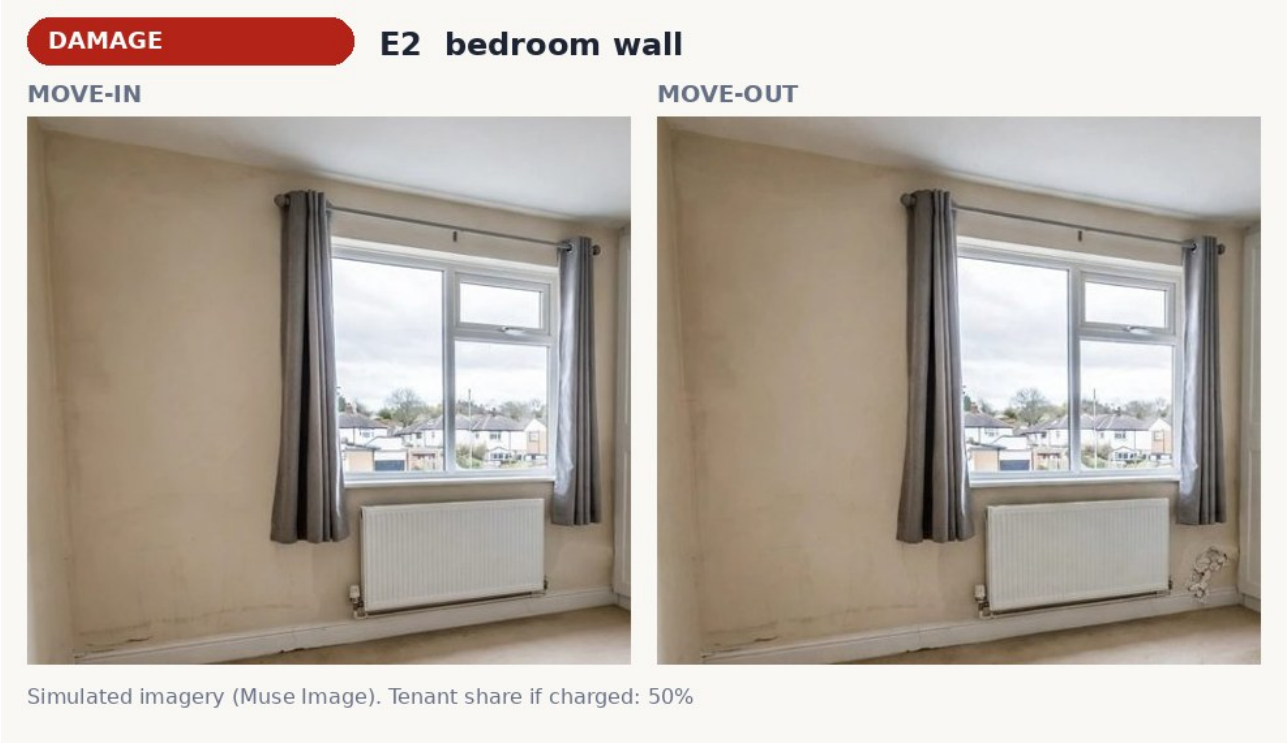
E1 · bedroom carpet · Damage · model confidence 82%

The bedroom carpet developed a large dark stain in front of the wardrobes during the two-year tenancy that was not present at move-in.

Carpet is expected to flatten and fade in high-traffic areas.

E2 · bedroom wall · Damage · model confidence 70%

The bedroom wall shows new scuffed and peeling paint patches to the right of the radiator at move-out that were not visible at move-in.

Paint lasts about 4 years; small nail holes and light marks are wear.

E1 – bedroom carpet stain in front of wardrobes: Part-accept. This is damage beyond fair wear and tear. To avoid betterment, cost must be apportioned by useful life. I accept 71%, based on 2 years' use of a 7-year life.

E2 – bedroom wall scuffed/peeling paint right of radiator: Part-accept. This is damage, not fair wear and tear. I accept 50%, based on 2 years' use of a 4-year life.

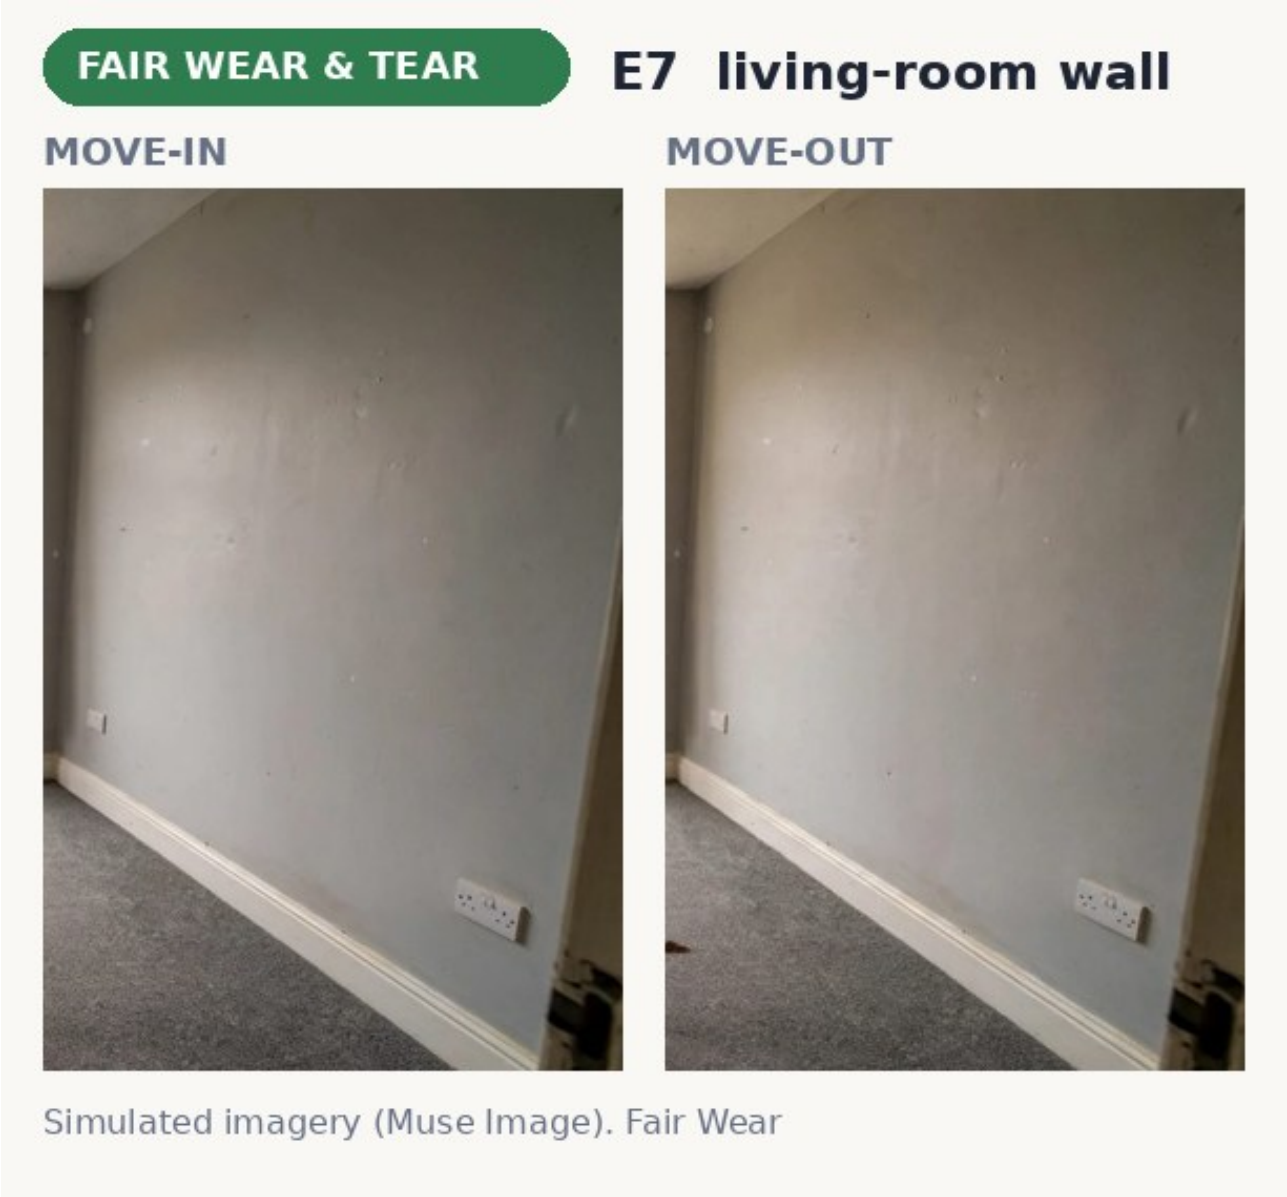
E6 · bathroom bath · Cleaning · model confidence 90%

The bath is intact but the white sealant has developed heavy black mould along the edges that was clean before.

Surface wear is expected; chips are damage.

E7 · living-room wall · Fair Wear & Tear · model confidence 70%

The living-room wall shows a few extra small nail-hole marks and light scuffs after two years consistent with normal use.

Paint lasts about 4 years; small nail holes and light marks are wear.

E6 – bathroom bath sealant black mould: Accept. This is cleaning. I accept 100% of the reasonable cleaning cost.

E7 – living-room wall nail holes and light scuffs: Dispute. After two years this is fair wear and tear from normal use. I accept 0%.
