## The Current: Site Report: 05.15.2020

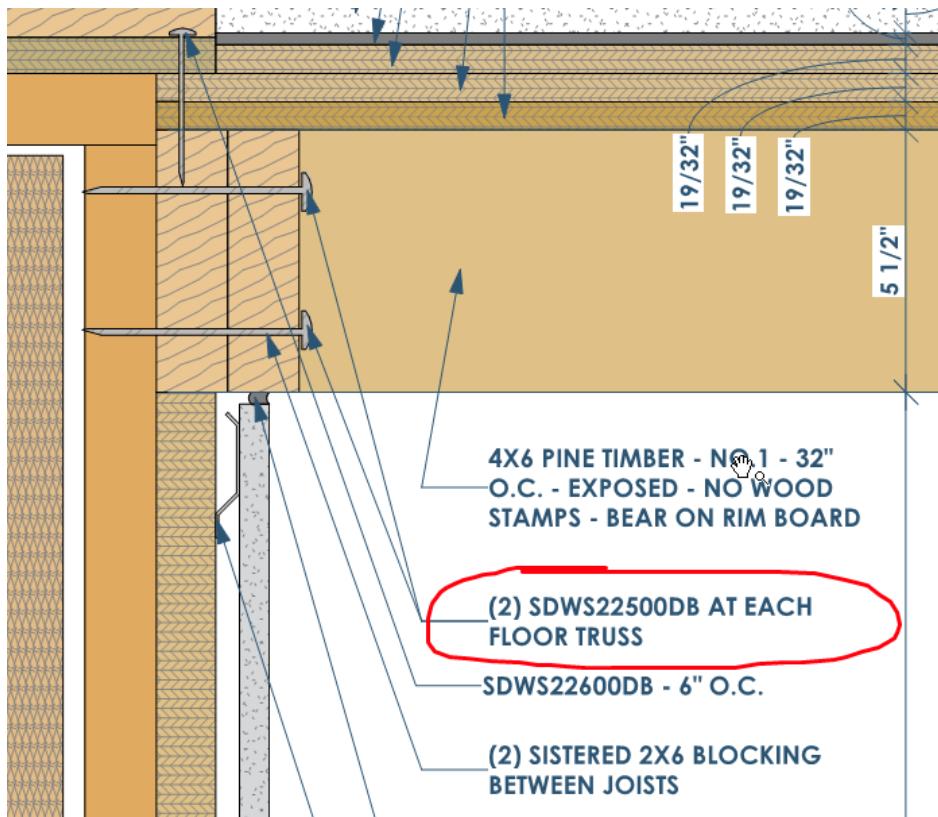
- There were a number of conditions throughout the project where the girder truss that supports the jack trusses at the corner conditons was not sistered together (or it doesn't appear they were) as outlined in the truss shops. See truss shops for exact detail for sistering
- There was a number of holddowns throughout the project that were missing. Confirmed with GC that they are still in the process of installing
- Blocking above rim board needs (2) SDWS22500BD at each truss--all floors and at roof. A number of locations only had (1) SDWS22500BD at each truss
