Strip View

IV   33305010000619

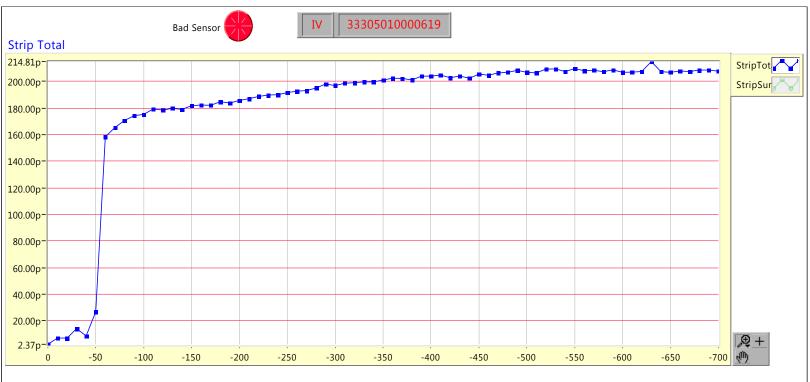
Bad Sensor

Itot(70V) HIGH = 10.0E+3
Itot(300V) HIGH = 10.0E+3
2 strips above 1uA at70V.
The rest have avg currentt of0.0E+0
2 strips above 5uA at 300V.
The rest have average current of 0.0E+0
