Strip View

Bad Sensor

IV   33305010000619

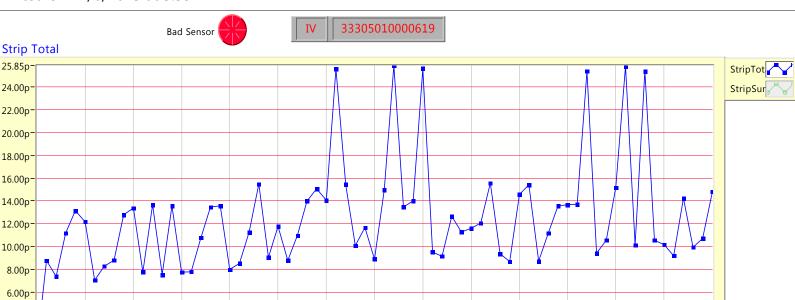
Itot(70V) HIGH = 10.0E+3
Itot(300V) HIGH = 10.0E+3
2 strips above 1uA at70V.
The rest have avg currentt of0.0E+0
2 strips above 5uA at 300V.
The rest have average current of 0.0E+0
