Bad Sensor

IV   33305010000619

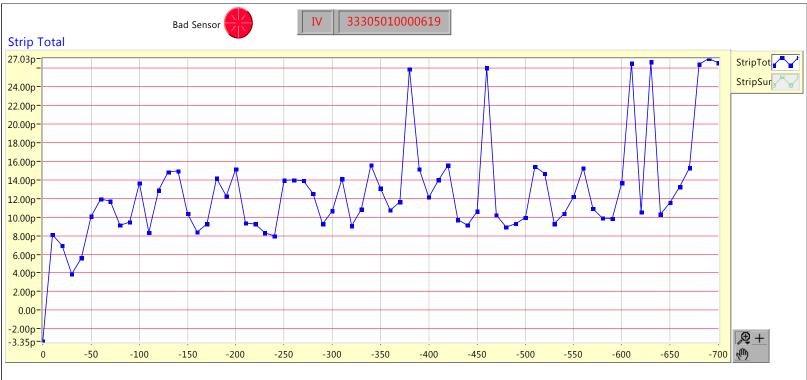
Strip
View

Itot(70V) HIGH = 10.0E+3
Itot(300V) HIGH = 10.0E+3
2 strips above 1uA at70V.
The rest have avg currentt of0.0E+0
2 strips above 5uA at 300V.
The rest have average current of 0.0E+0
