SnapClaim case study

Terrace-slab crack — measured vs guessed

Ref SC-25D35C5E · 2026-11-02 · scale: 2 INR coin, 25 mm, same plane as the crack

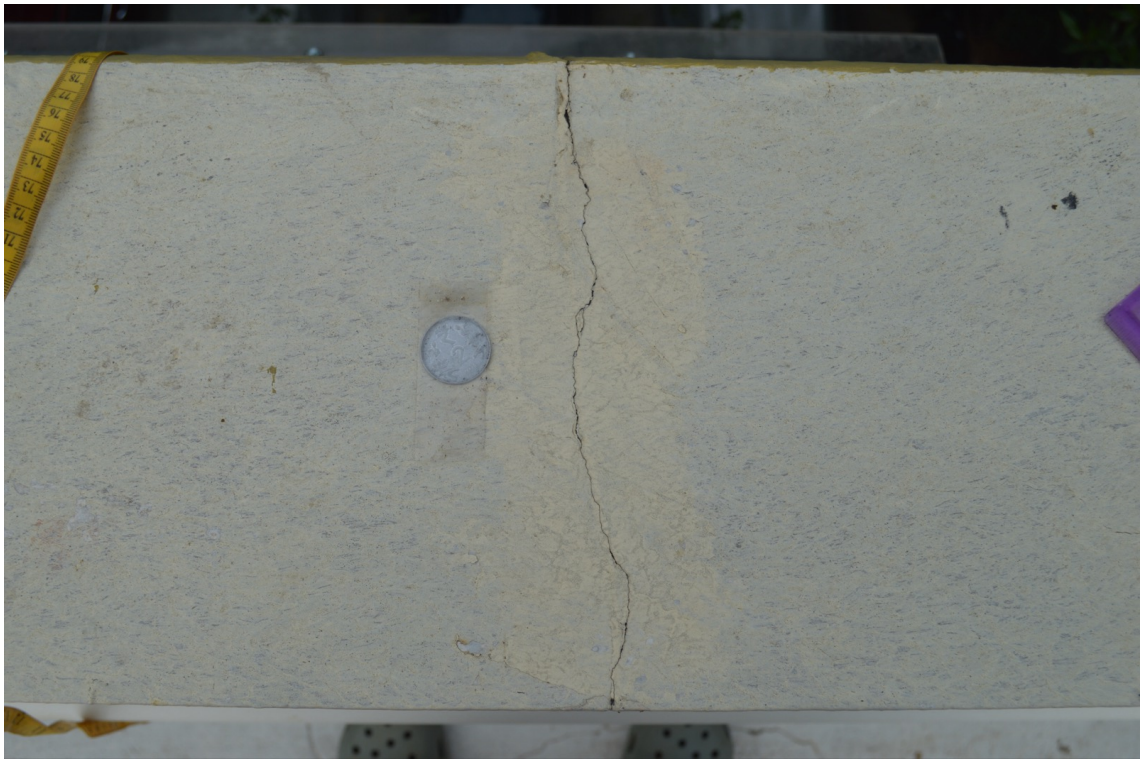
Photo with tape (ground truth)

Measurement	Value	Status
Crack length	218.5 mm	Confirmed
Crack width	3 mm	Confirmed
Surface affected	0.73 %	Confirmed
Area	6.51 cm2	Confirmed
Severity	significant	Confirmed

Tape 227 mm vs measured 218.5 mm (inside ±10%) vs photo-alone guess 315 mm (outside ±10%). Bench case terrace-slab-tape-01.
