CLAIMANT'S DESCRIPTION

> *“crack near the slab”*

Findings (1)

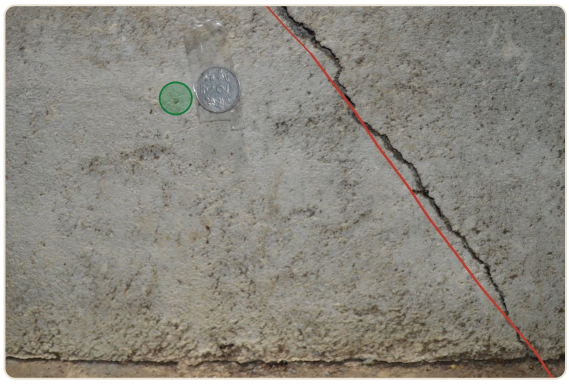
Figure 1a · Captured photo, full frame

LENGTH	WIDTH	AREA	SURFACE AFFECTED	SEVERITY
229.3 mm	3.3 mm	7.66 cm²	0.76% of component	SIGNIFICANT
Confirmed	Unverified	Confirmed	Confirmed	area · length · regions
R005	R006	R004	R002	Confirmed
				R007

Width is unverified: no reference width to check it against, so read 3.3 mm as indicative.

Near the slab, a significant crack covers 0.76% of the component, extending 229.3 mm.
