CASE STUDY

Terrace-slab crack — measured vs guessed

Ref SC-25D35C5E · 2026-11-03 · scale: 2 INR coin, nominal 25 mm issue spec (same coin ruler-read 24 mm — sizes vary by issue; typed diameter wins). Sensitivity at 24 mm: 228.0 mm / 3.1 mm / 7.08–7.09 cm².

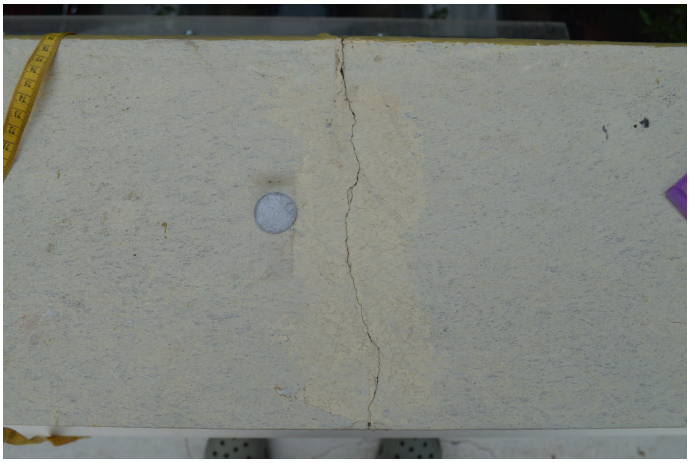
Figure 1 — photo with tape: the measuring tape held along the crack is the ground truth.

Item	Value	Evidence	Status
Crack length	237.5 mm	R005	Confirmed
Crack width	3.2 mm	R006	Unverified — no width ground truth
Surface affected	0.73 %	R002	Confirmed
Area	7.69 cm2	R004	Confirmed
Severity	significant	R007	Confirmed

Value	Reading
Thread truth	238.8 mm	ground truth (thread path ±4 mm)
SnapClaim measured	237.5 mm	inside ±10%
Photo-alone guess	315 mm	outside ±10%
Straight span	227 mm	printed, unscored (err 10.5 mm)
