2016.0 RANGE ROVER (LG), 204-04

WHEELS AND TIRES

DIAGNOSIS AND TESTING

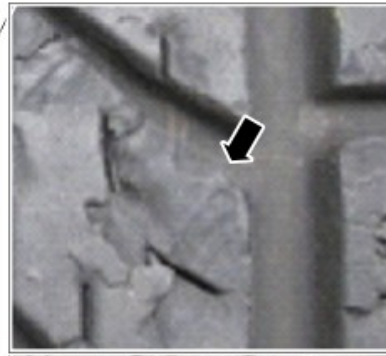
E157078

Typical example of a serviceable tire exhibiting chip and chunk phenomenon

Tire Chip and Chunk is a phenomenon that may develop on the tire tread when vehicles are driven on rough gravel or aggressive road surfaces. Typically the tread may lose small pieces of tread rubber within and around the periphery of the tread block. This loss of rubber ultimately leads, with extended usage, to an overall rough appearance to the tread area of the tire.

If the level of chip and chunking is excessive or overall tire condition is poor the tire should be treated as any damaged/punctured tire. Where detrimental damage to the tire is evident, it must be reported to the customer with recommendations to accordingly replace damaged tires.

- Conduct a thorough evaluation of the tire condition and, where no detrimental damage has occurred, inform the customer that the chip and chunk condition does not affect the overall tire integrity or significantly affect performance
- Inform the customers of the conditions that generate chip and chunk

Where the tires do not exhibit excessive chip and chunk, cuts, sidewall bulges and are in generally good condition the customer should be advised that the condition does not affect the overall tire integrity or significantly affect performance and as such are serviceable.
