TATA MOTORS LTD 1512G LPT DCR48CBC 125B6M5

VEHICLE DETAILS

SUMMARY

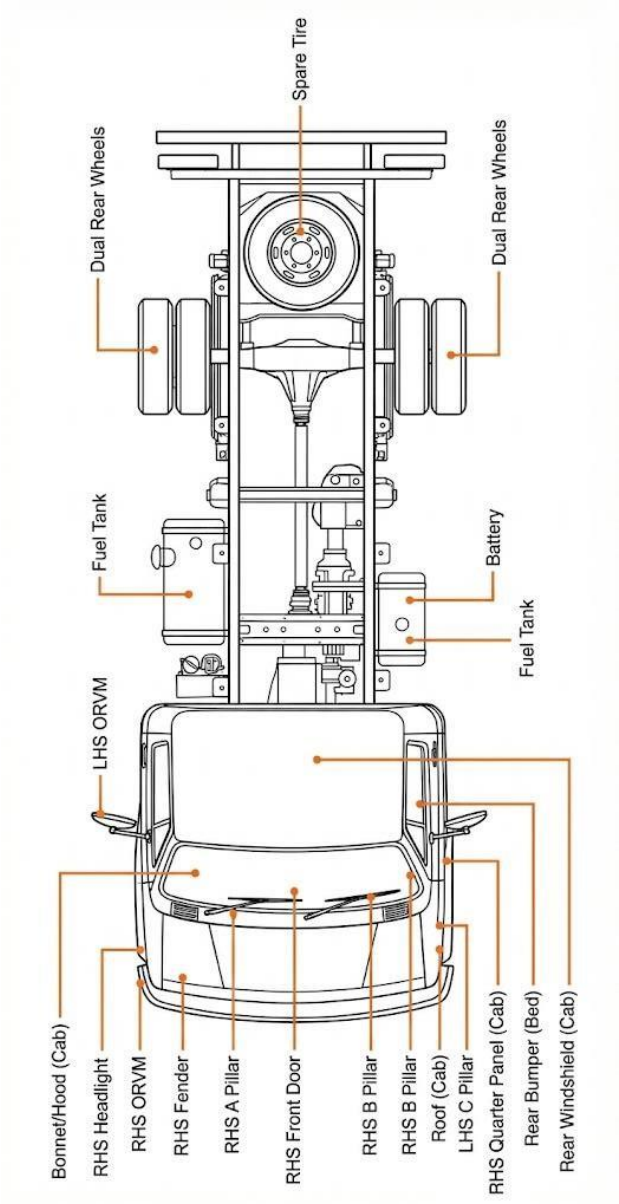
Part	Sub-Part	Status	Remarks / Condition
Bumper	Front / Rear	!	Front Bumper Slight Damage Front Bumper Left Side Slight Dent
Cabin Panels	LHS / RHS	✓	
Bonnet / Hood	—	✓

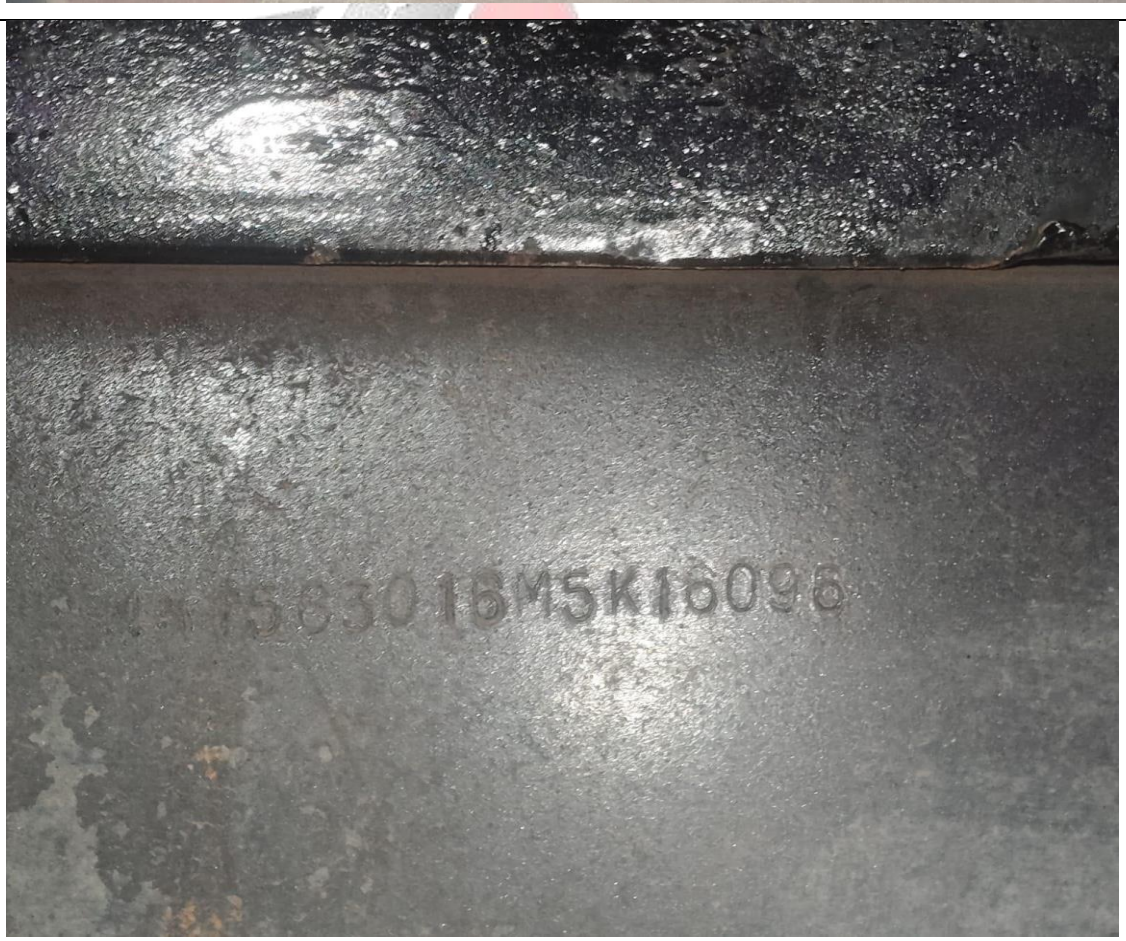
TYRES

Roof (Cab)	—	✓	
Fender	LHS / RHS	✓	
Doors	LHS / RHS	✓	
Windshield	Front / Rear	✓	
Pillars	A / B / C	✓	
Load Body Floor	—	✓	
Side Panels	—	✓	
Tailgate	—	✓	
Chassis Visible Area	—	✓	
Tyre	1	✓	60-70%
Tyre	2	✓	50-60%
Tyre	3	!	20-30%
Tyre	4	✓	50-60%
Tyre	5	✓	50-60%
Tyre	6	✓	60-70%
Tyre	Spare	!	10-20%
Wheels / Rims	—	✓
