NATIONAL RAILWAY AUTHORITY

AI TRACK INSPECTION REPORT

Report ID: INSP-SIM-20260723_210711
Date: 2026-07-23 15:37:13
Status: DEFECTIVE

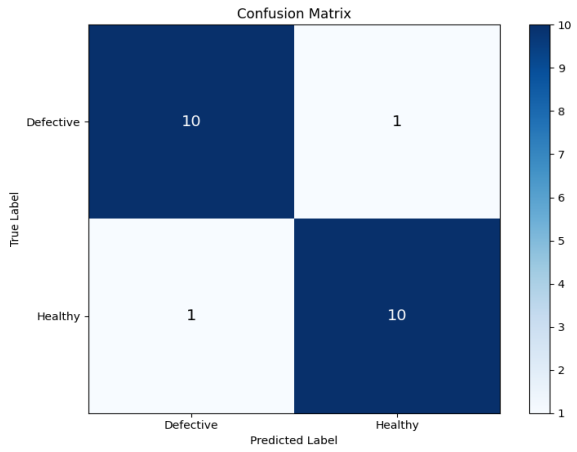
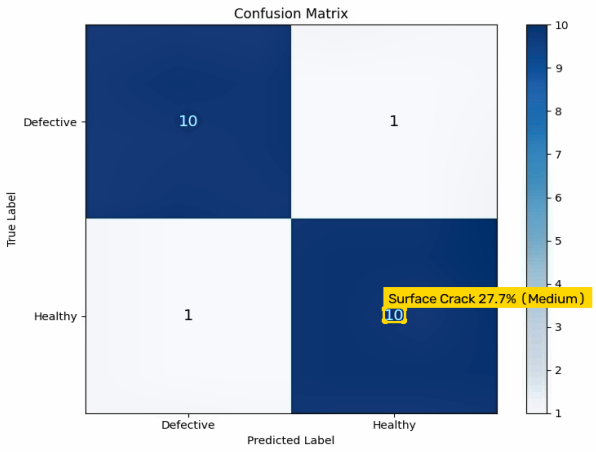
Original Rail Track Image	YOLOv8 Bounding Box Detection

Defect Type	Confidence	Severity	Bounding Box (x1,y1,x2,y2)	Maintenance Recommendation
Surface Crack	27.68%	**Medium**	[504.2, 404.5, 530.0, 423.1]	Schedule non-destructive testing (NDT) and surface grinding.
