U.S. Department
of Transportation
Federal Railroad
Administration

Rail Crossing Violation Warning

C-V2X Field Test & Evaluation Report

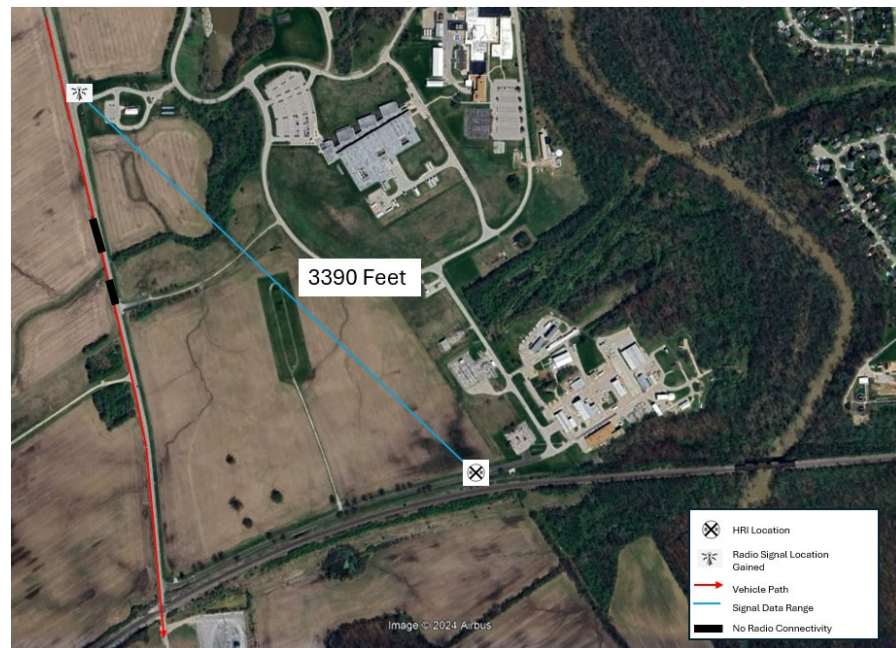
Figure 13. Southbound Approach (Source: Google Maps)

The VBS was able to process RBS signals at a distance of around 3390 ft (1.033 km). As the vehicle continued the travel south, communications were lost on two occasions. On both of these, it is suspected that the presence of vegetation obstructed the field of view of the vehicle antenna and the RBS antenna.

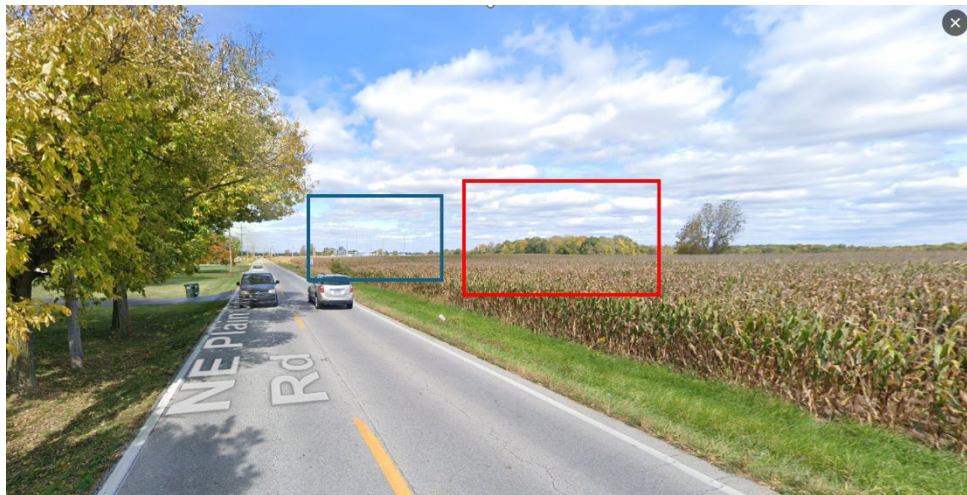
Figure 17. Northbound Obstructions (Source: Google Maps)

The line of sight from this approach has several obstructions:

- Large Wooded area. See the red box in Figure 17
- Electric Power Plant. See the blue box in Figure 17

It is suspected at first the signal was blocked by the trees located both in the wooded area as well as along the south side of the test track. Once the vehicle cleared the wooded area, it is possible that the adjacent power plant caused interference with the signal.

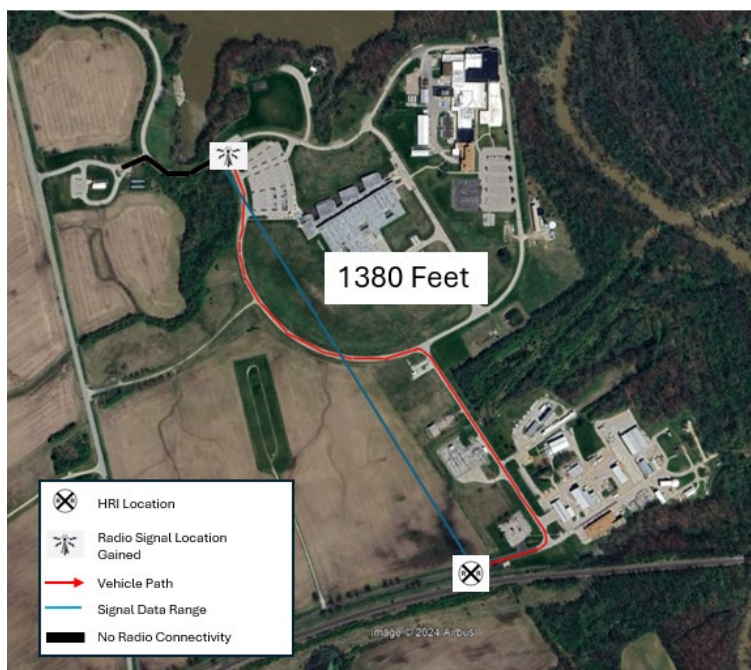
Figure 18. Urban Setting Approach (Source: Google Maps)

The urban setting approach was designed to have the vehicle approach the RBS using roads where buildings and vegetation were present. Figure 18 shows how radio connection was achieved once the vehicle cleared a wooded area on its right and was able to have LOS of the RBS. This represents a distance of 1380 ft (420.6 m). The vehicle proceeded to approach the crossing and radio connectivity remained throughout.

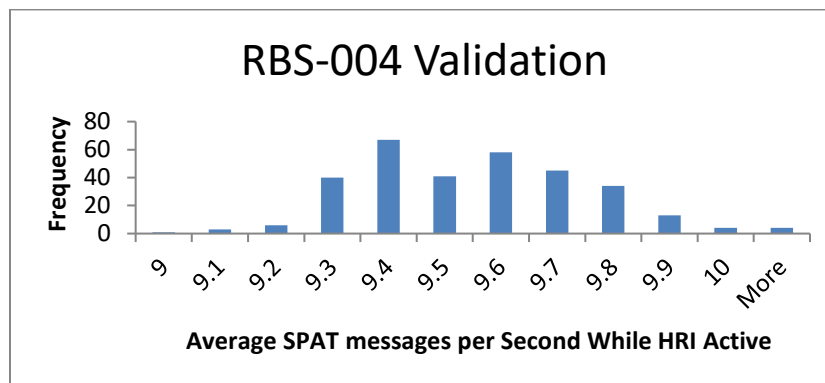
Figure 20. Average SPaT Message Sent by the RBS Per Second (Source: Battelle)

While the analysis shows the system meets requirement RBS-007, it fails to meet requirement RBS-004 by not achieving a rate of 10 SPaT messages per second.

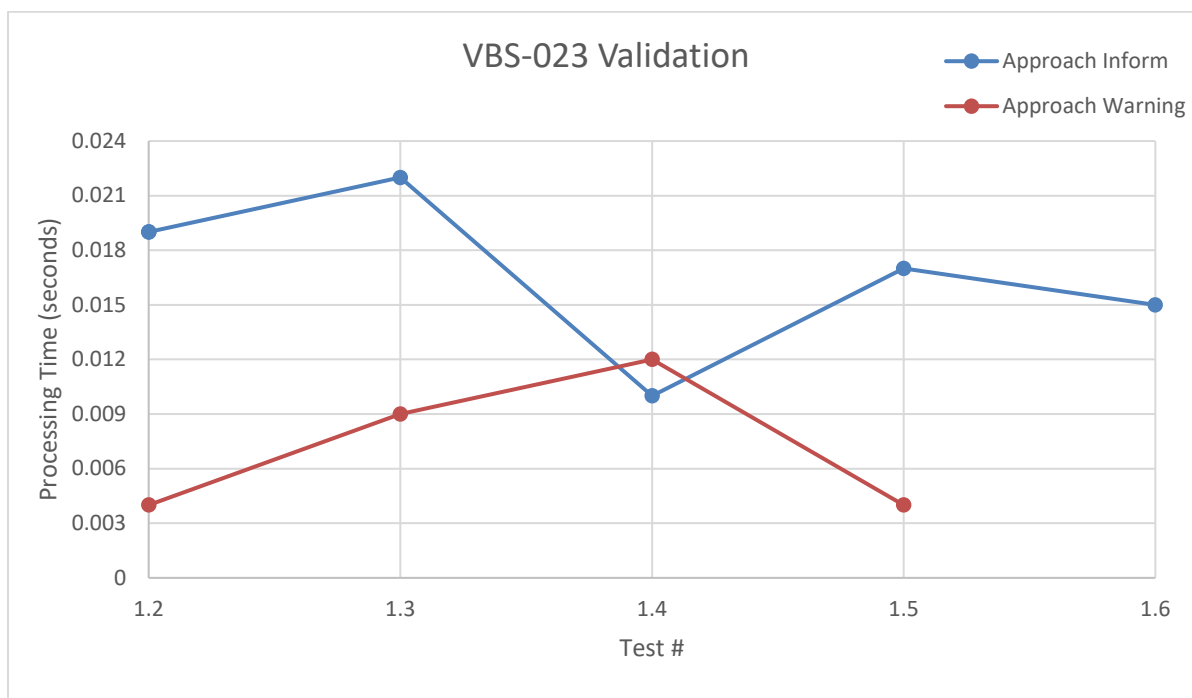
Figure 21. Processing Latency (Source: Battelle)

The analysis shows that the processing latency for tests 1.2-1.6 was well less than the 85 ms. required by VBS-23.
